# The Restoration of Mangal Bahudvara Caitya. A Tashi Gomang Stupa

THE RESTORATION OF  
MANGAL BAHUDVARA CAITYA  
TASHI GOMANG STUPA

SVAYAMBHU, KATHMANDU VALLEY WORLD HERITAGE SITE

EDITED BY DAVID C. ANDOLFATTO AND THOMAS SCHROM  
WITH CONTRIBUTIONS BY NUTANDHAR SHARMA

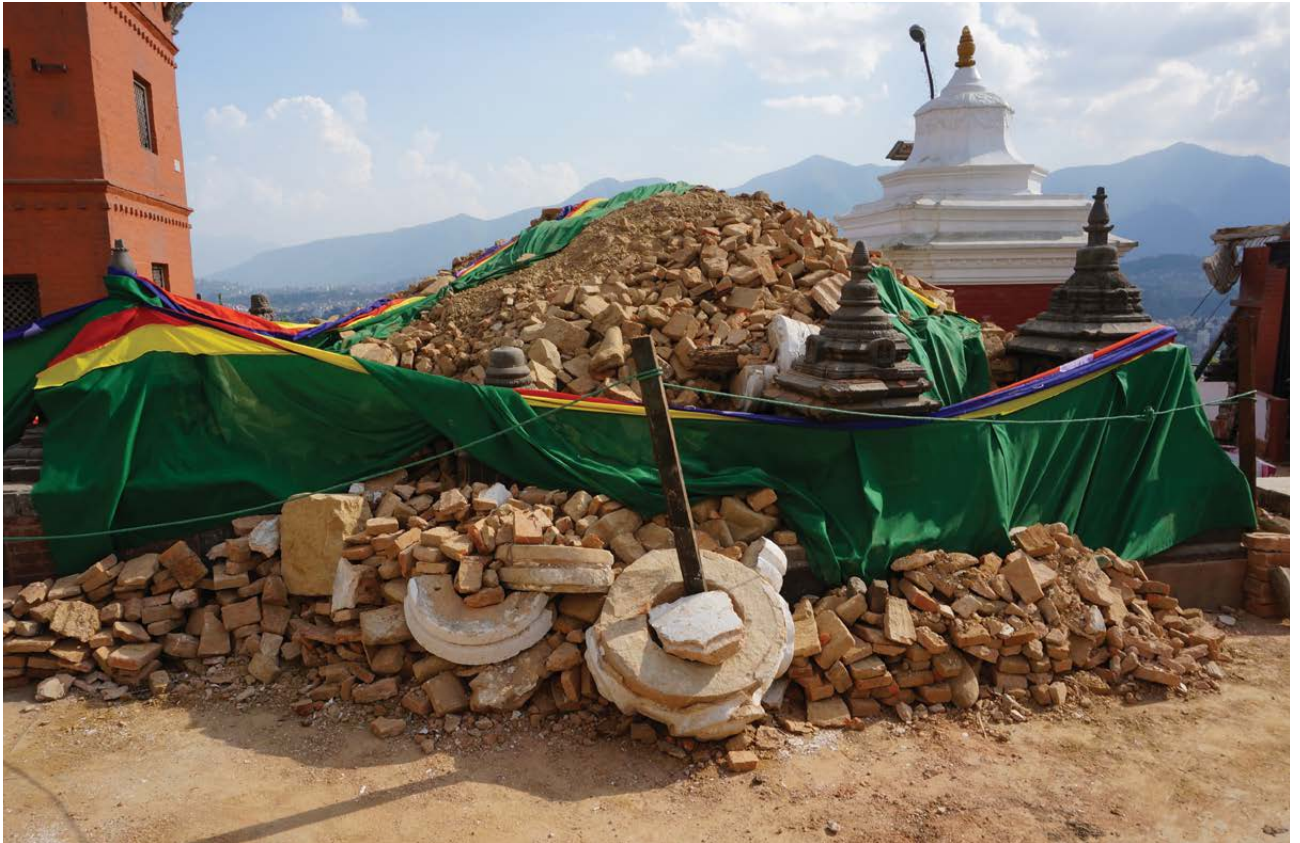
**RUBBLE OF TASHI GOMANG STUPA**

Two fragments of the lower part of the stone finial are seen in the foreground. Partly obscured by the caitya in the center lies the upper part of the finial.

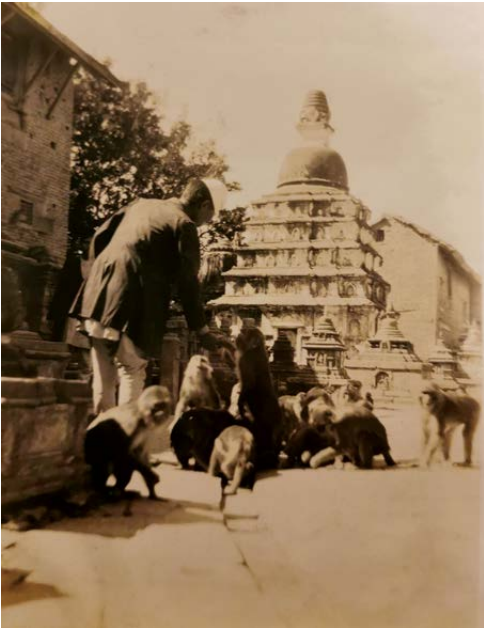
**TASHI GOMANG, VIEW FROM THE EAST**

Similar to the image on the right, the top section of the pinnacle is missing.  
 Photograph from the album of Major D.C. Monro | ca.1931  
 Courtesy of Galerie le Toit du Monde (Paris)

In early 2020, two historic photographs of Tashi Gomang surfaced, one from the collection of Major D.C. Monro, who visited Nepal in the early 1930s, and another from an unknown source in Nepal. It is interesting to note that in both photographs the top part of the pinnacle is missing and even the black mould stains on the exterior plaster look very similar.

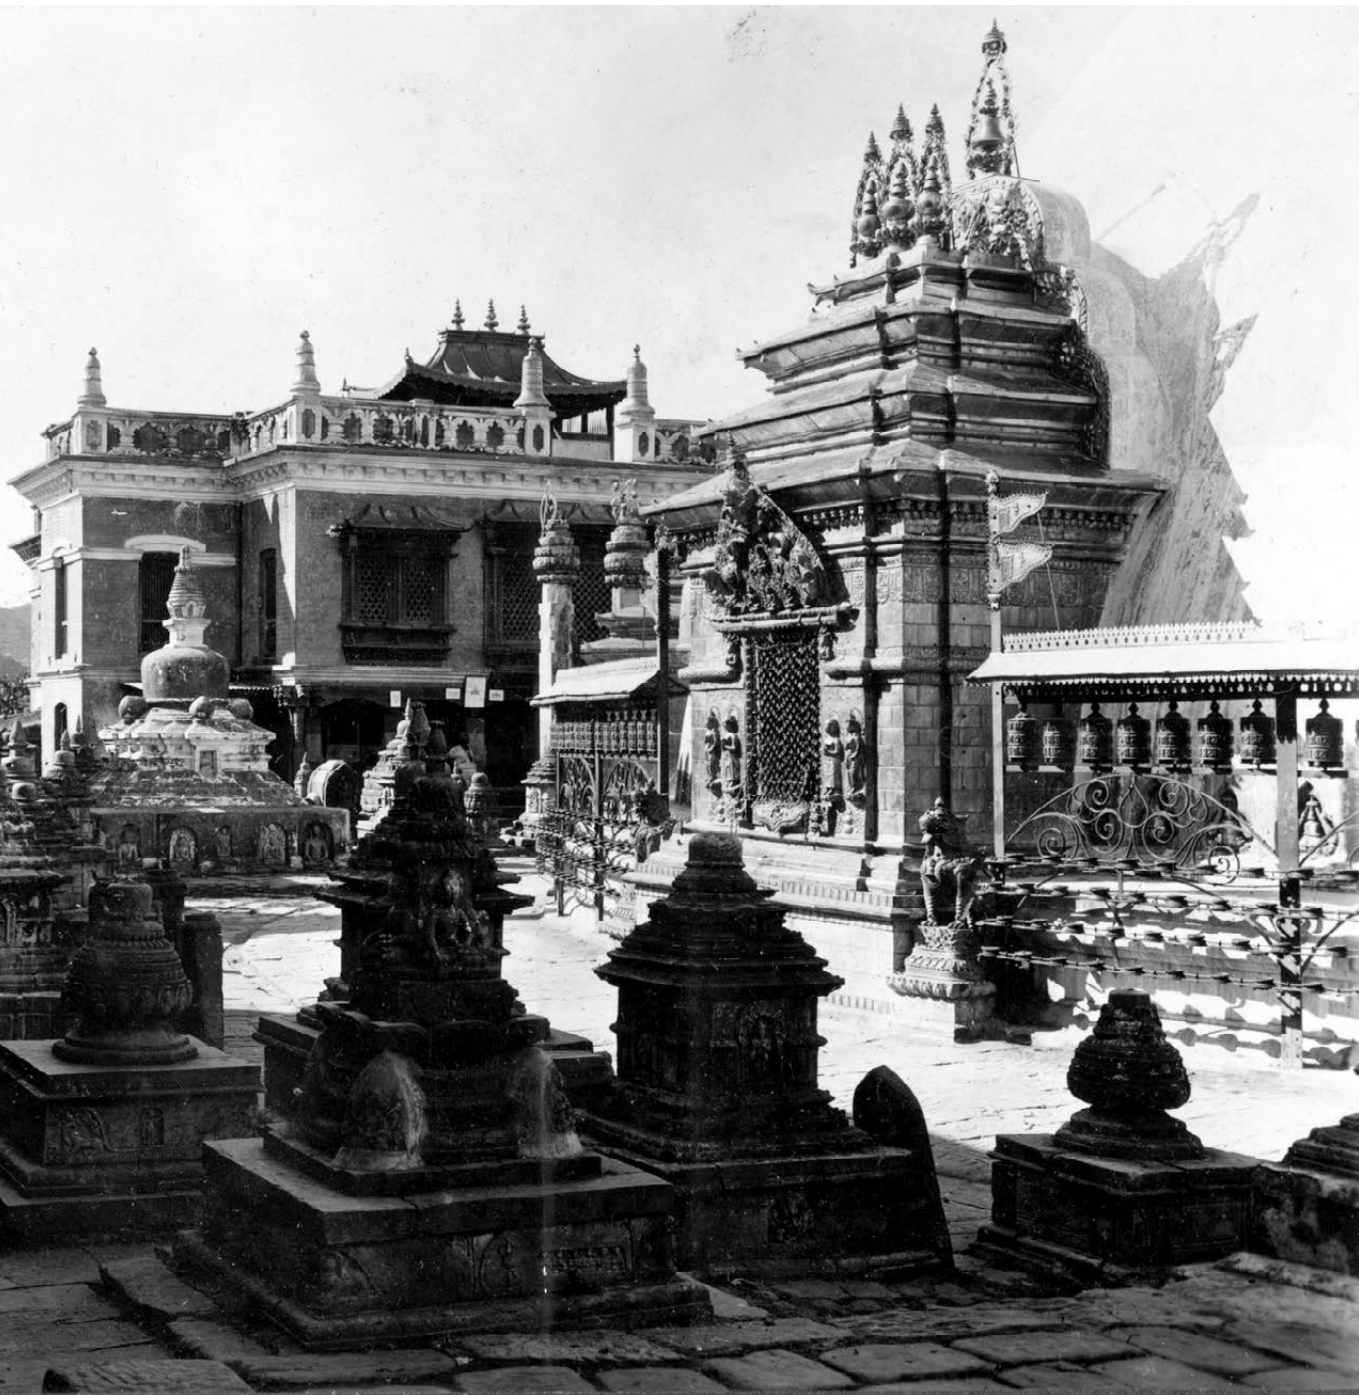
**TASHI GOMANG STUPA AND THE SOUTHERN SECTION OF THE MAIN STUPA**

This undated photo shows the main stupa's Shrine to Ratnasambhava on the right. Tashi Gomang is in a dilapidated state with the upper

part of its pinnacle missing. The stupa had not been whitewashed for a while as indicated by heavy black mould on its dome and facade.

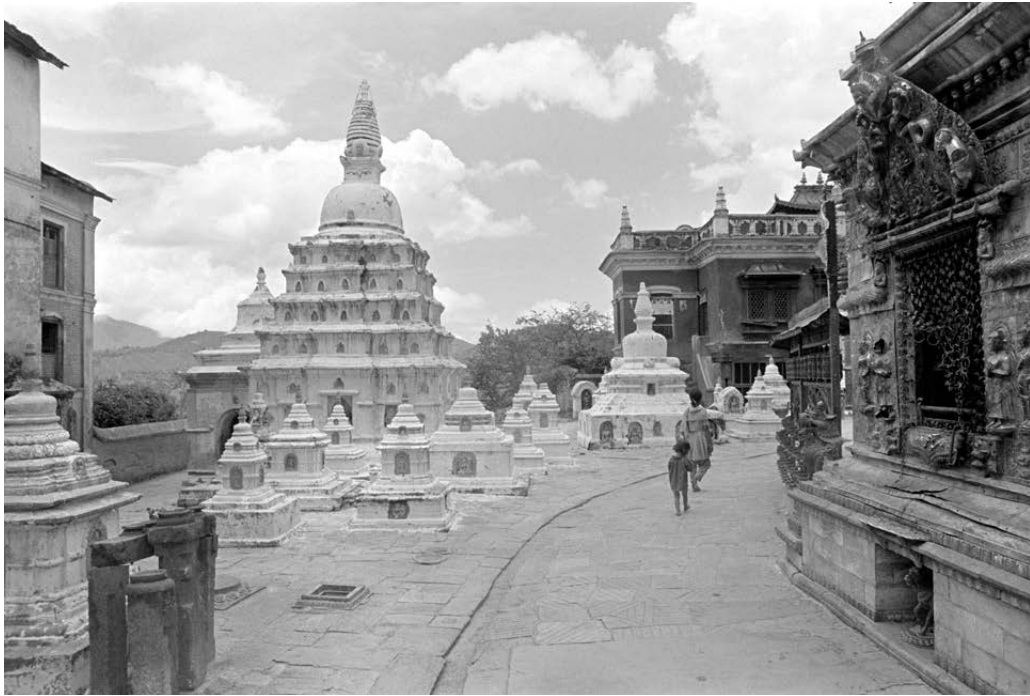
**VIEWS FROM THE EAST AND THE NORTH**

The buildings to the left and behind Tashi Gomang were damaged by a landslide in the late 1970s and have since been dismantled.

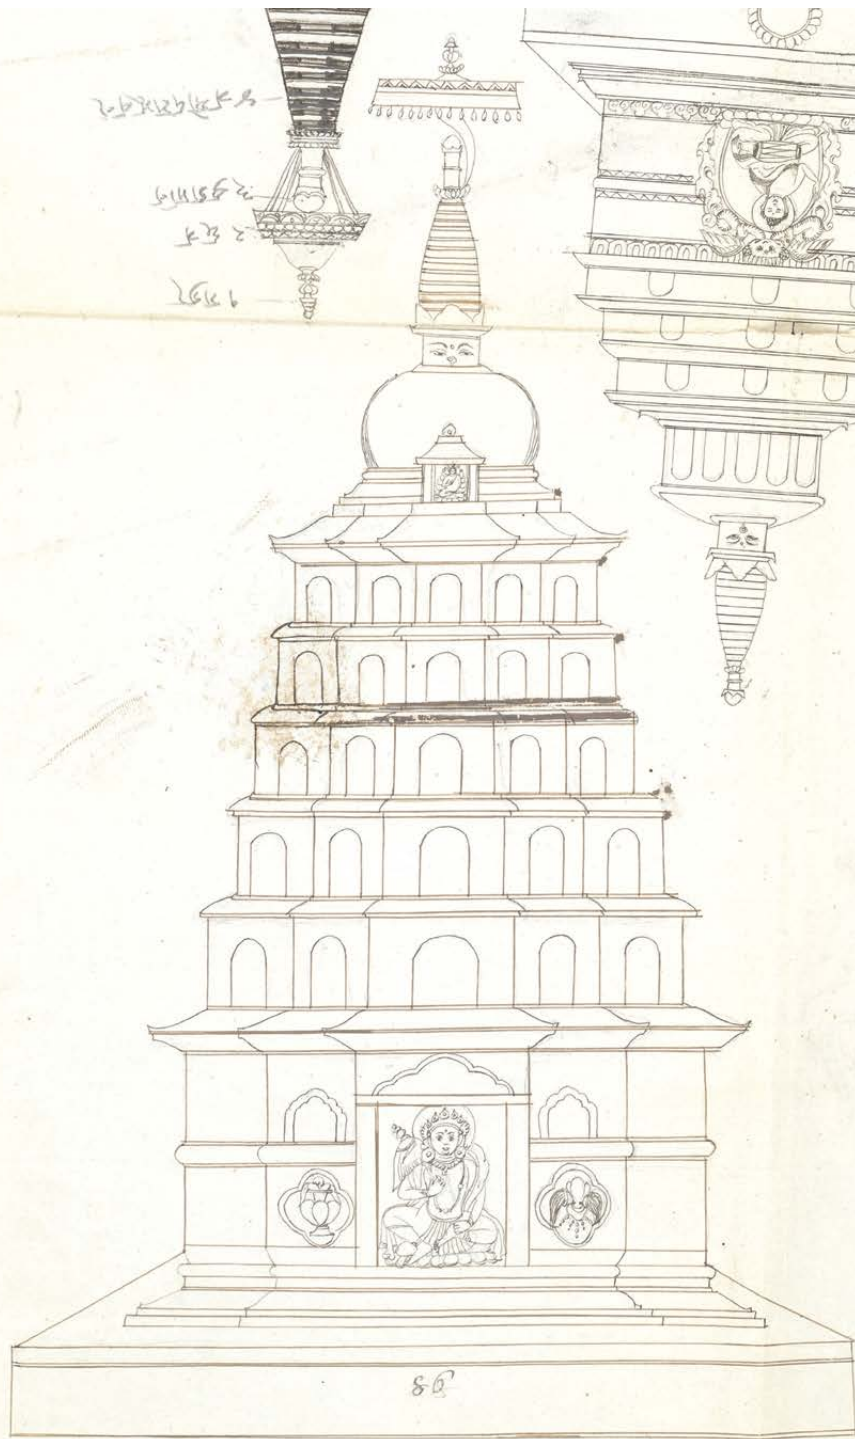
**"A SMALL KUTAGAR CHAITYA AT GÖPÜCCH", DETAIL**

The caption identifies the stupa to be at "Gopucch" which is an alternate name of Syayambhu. Today, Tashi Gomang has only five levels for niches rather than the six depicted in the sketch and although the central sculpture can be identified as Vaisravana/Kubera, Chitrakar's drawing of the sculpture differs in several details. The two emblems on either side do not match with what we see today. This indicates that the stupa must have undergone at least one major rebuilding, possibly during the 1875 renovation when the reliquary was inserted. It is quite possible that at that time the stupa was rebuilt with one less level and that old sculptures were replaced with new ones.

The inscription on the metal casket found in the caitya refers to it as “Maṅgala Caitya”, which means “auspicious caitya”. The caption on the drawing by Raj Man Singh Chitrakar (see page 29) identifies the stupa as “A small Katagar Chaitya at Gopucch”. The Devanagari caption पंचतला कुतागार चैत्य स्वयम्भू आस् पास् reads: paṃcatalā kutāgāra caitya svayabhū (corr. svayambhū) ās pās: Five storey kutāgāra (corr. kūṭāgāra) caitya around Svayambhū. Niels Gutschow translates kutāgāra as the “celestial palace”. The exact meaning is somewhat elusive: *kūṭā* can be interpreted as “prominent” or “projection”, e.g. a peak or mountain; *gāra* meaning “house”.

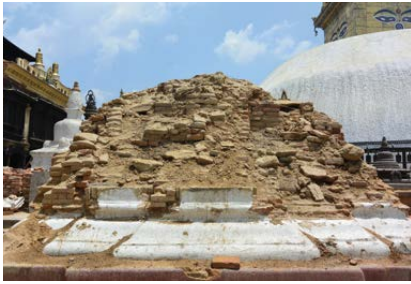
**SOUTH ELEVATION**  
© UNESCO | D. Andolfatto | May 27, 2015

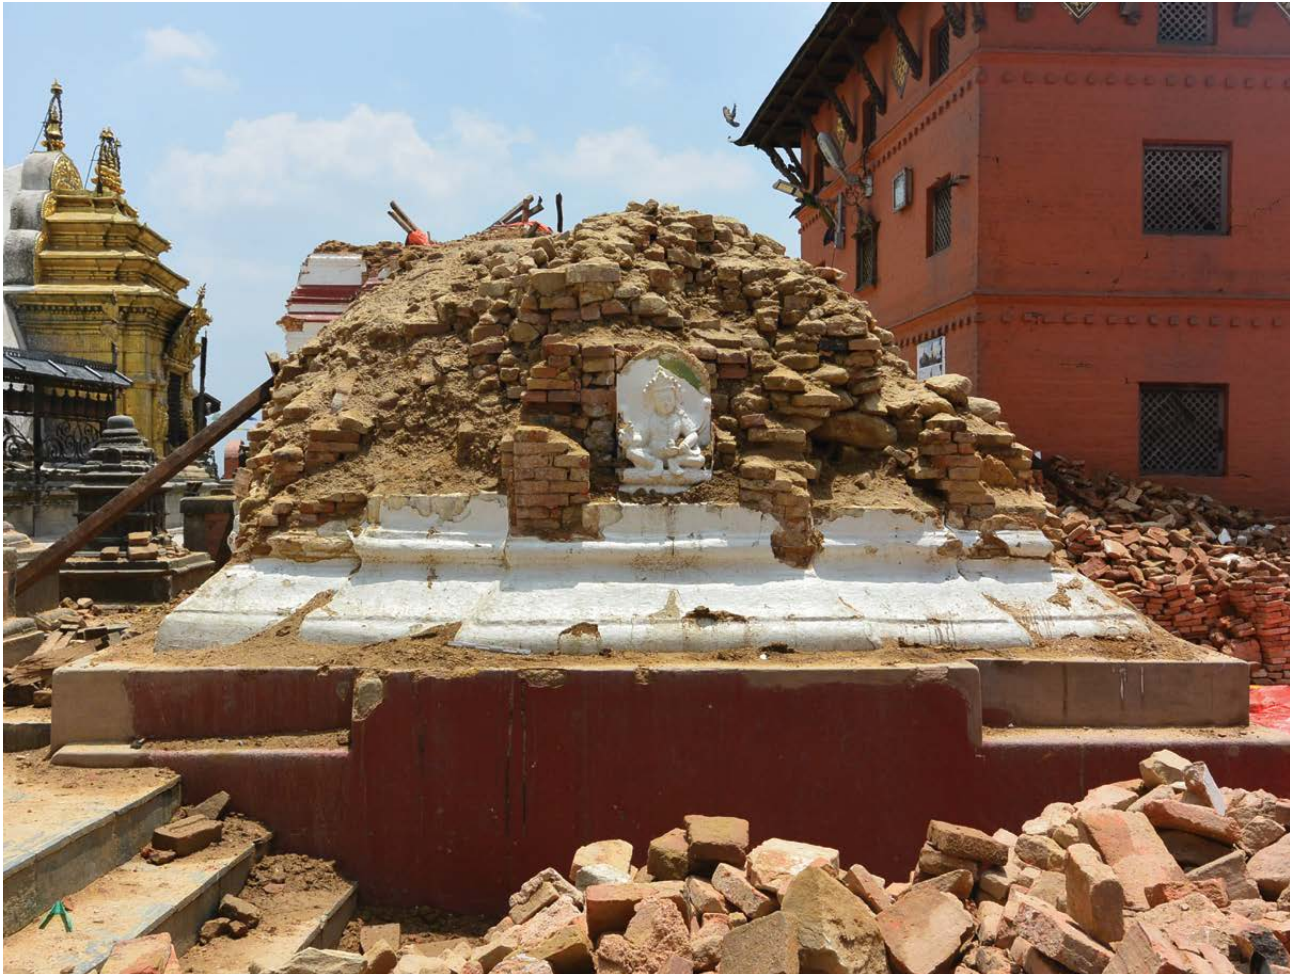
**WEST ELEVATION**

The statue of Virupaksa, King of the West, had remained in situ. The area around the stupa has already been cleaned and at the time this photo was taken bricks can be seen stacked in the background. Work on dismantling the “stump” is yet to be started.

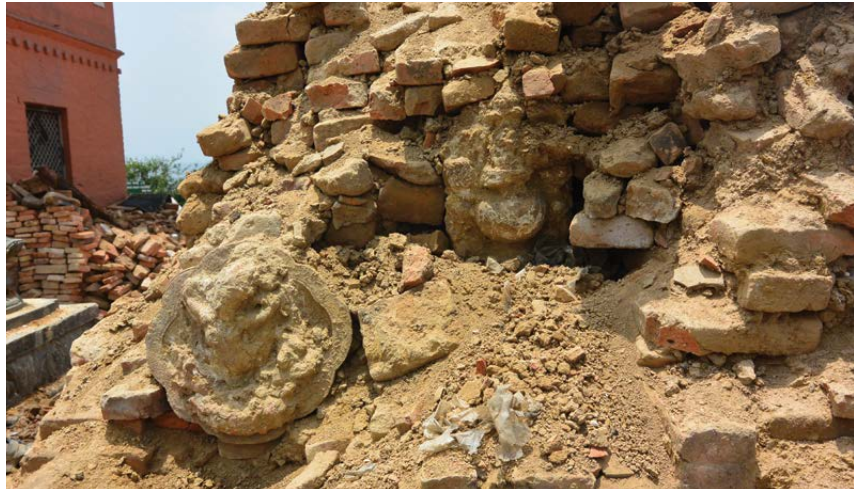
**VIEW FROM THE EAST**

A small opening indicates the access to one of the L-shaped cavities.

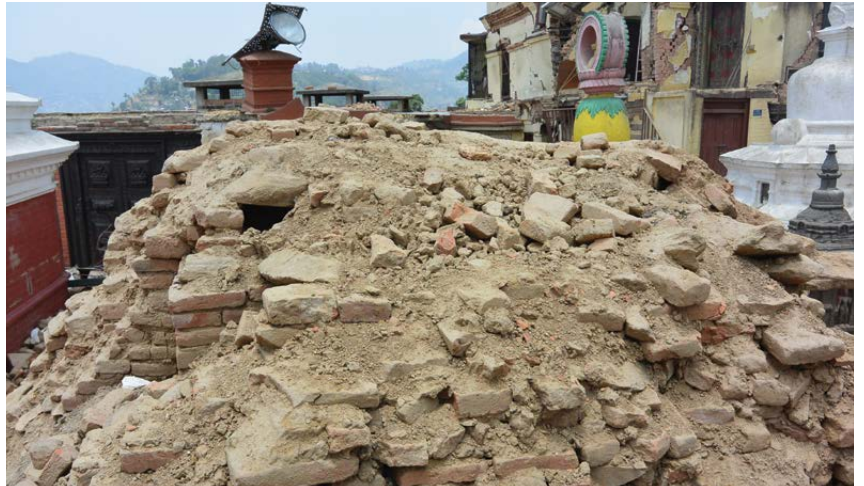
**VIEW FROM THE SOUTH**

The poor quality of masonry is evident in this detail of the caitya's southern structure.

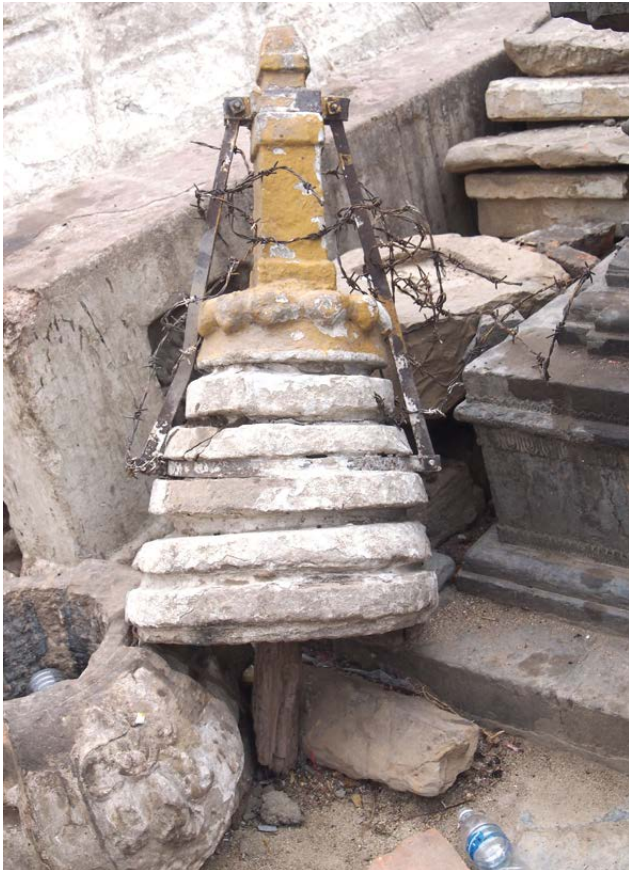
**BROKEN FINIAL**

The finial was already damaged before the earthquake and had been mended with a metal strap. The barbed wire had been installed to deter monkeys from climbing on the finial. Fragments of the central timber post can be seen on the bottom.

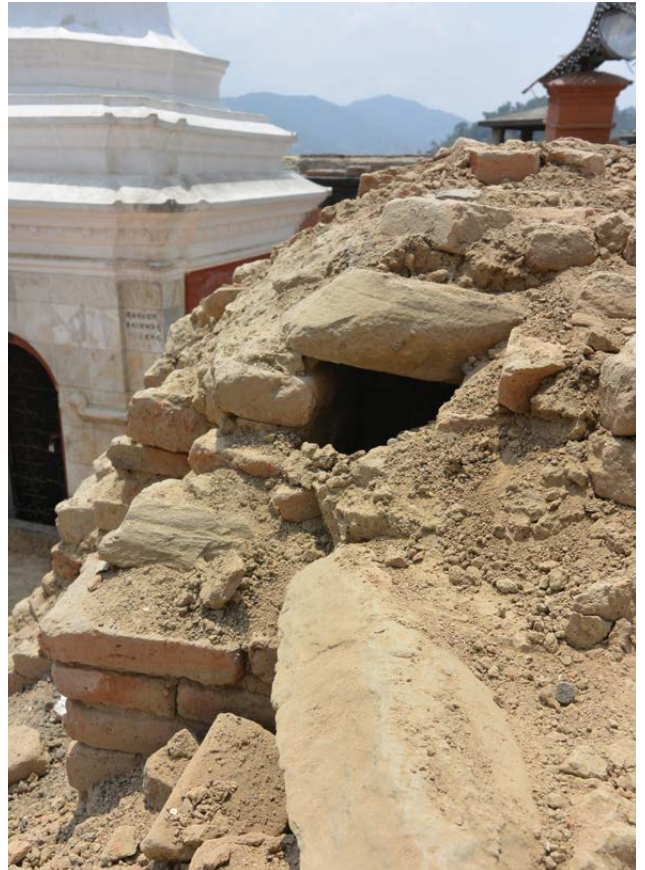
**SOUTH-EAST CORNER**

This image illustrates the unstable condition of the monument. At the center is a cavity that held numerous *tsbas*.

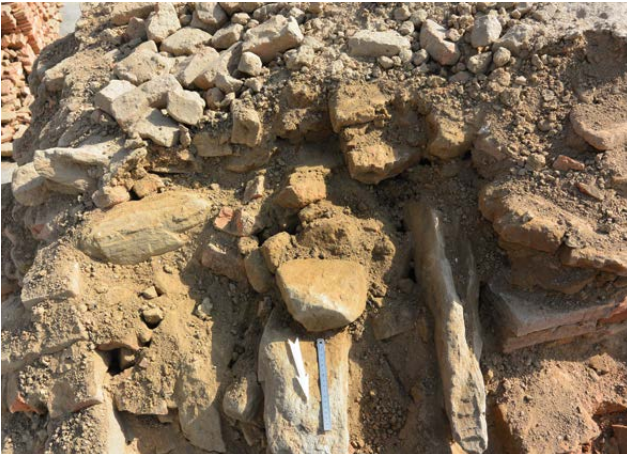
**VIEW FROM THE NORTH**

This image illustrates the poor state of construction. The stupa was built with a mixture of broken brick and stone not properly connected with mortar.

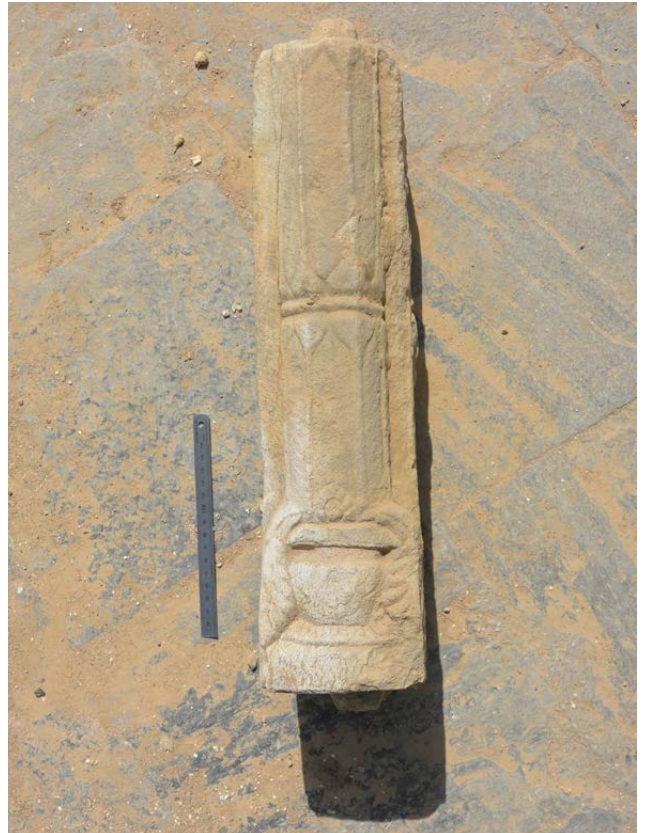
**STONE PILLAR**

This stone fragment was not part of one of the caitya's niches.

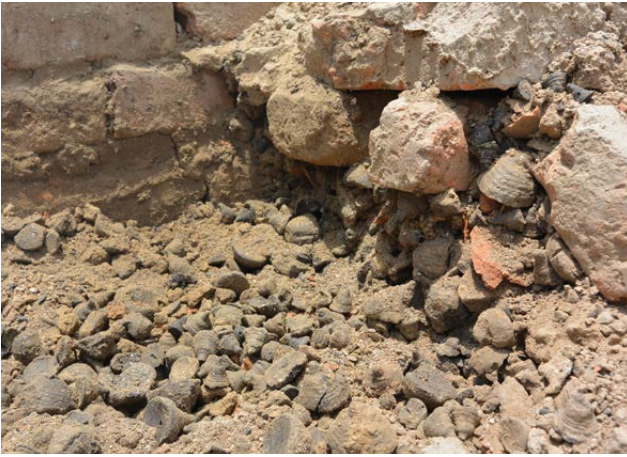
**DETAIL OF THE MASONRY**

Voids in the stupa were filled with *tsha-tshas* and sand.

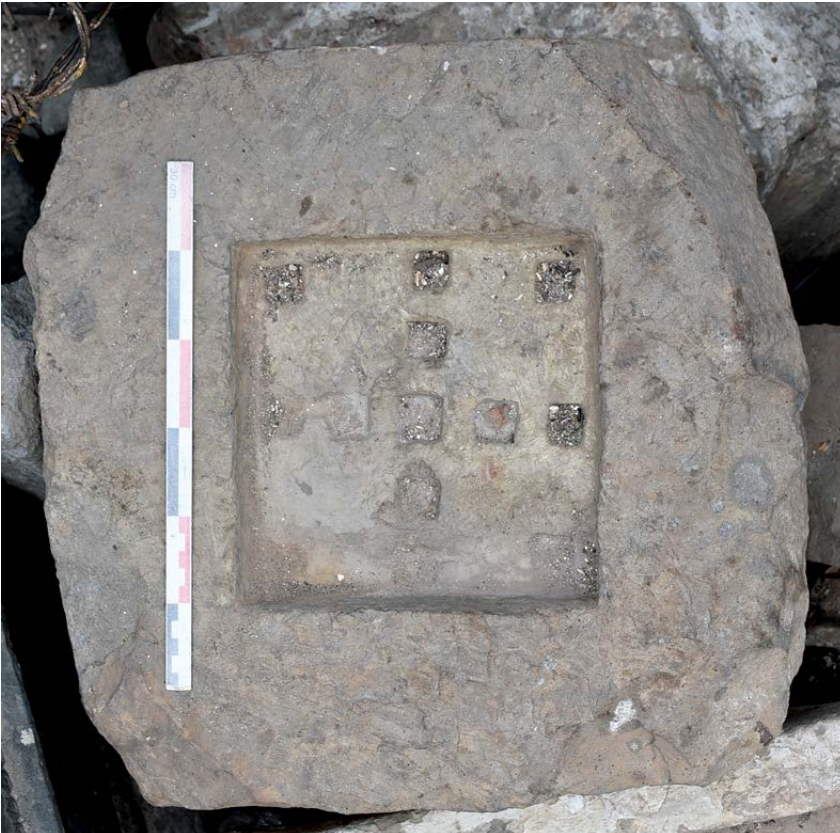
**DEPOSIT STONE**

Nine square cavities are arranged in a cross pattern and four additional squares are carved on each corner. Such deposit stones are known to hold nine kinds of gems (Skt. *navaratna*), which represent the nine planets, or astral phenomena: a ruby represents the sun (Skt. *Sūrya*), an emerald Mercury (Skt. *Budha*), etc. However, no gems were found that could be connected to this deposit stone.

The stone was found next to a copper reliquary (swmoi-215) in the collapsed caitya's rubble.

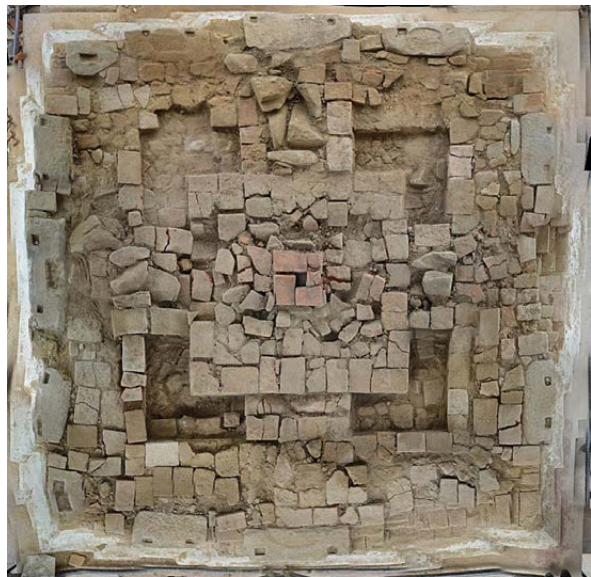
**LEVEL B, VIEW FROM ABOVE**

The shaft with its central opening can be clearly seen.

The core of the masonry contains a vertical shaft. This could be a merely symbolic structure or it might have had a practical application. Dominique Baudais of INRAP (France) suggests that the central shaft could have served as a measuring point, helping the masons to achieve the regular symmetrical shape of the caitya. A wooden stick could have been placed in the small hole with a string attached to it. Knots on the string would have allowed the measurement of uniform distances in all four directions.

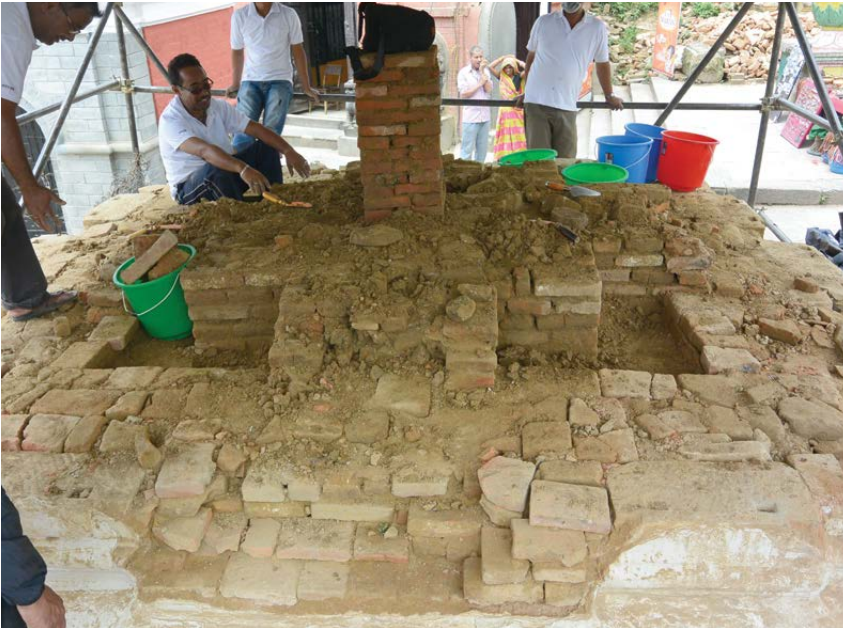
Four L-shaped cavities with an average height of 100 cm were found near the four corners. The cavities were covered with large stone slabs and bricks. The north-west, south-east and south-west cavities were completely filled with *tsha-tshas*, while the one on the north-east had partly collapsed in the earthquake. At the centre, the square brick core has wall projections facing the cardinal direction. The arrangement thus creates an architectural mandala, enshrined within the stupa.

**THE CENTRAL SHAFT AND L-SHAPED VOIDS**  
View from the east  
© UNESCO | D. Andolfatto | Aug 29, 2016

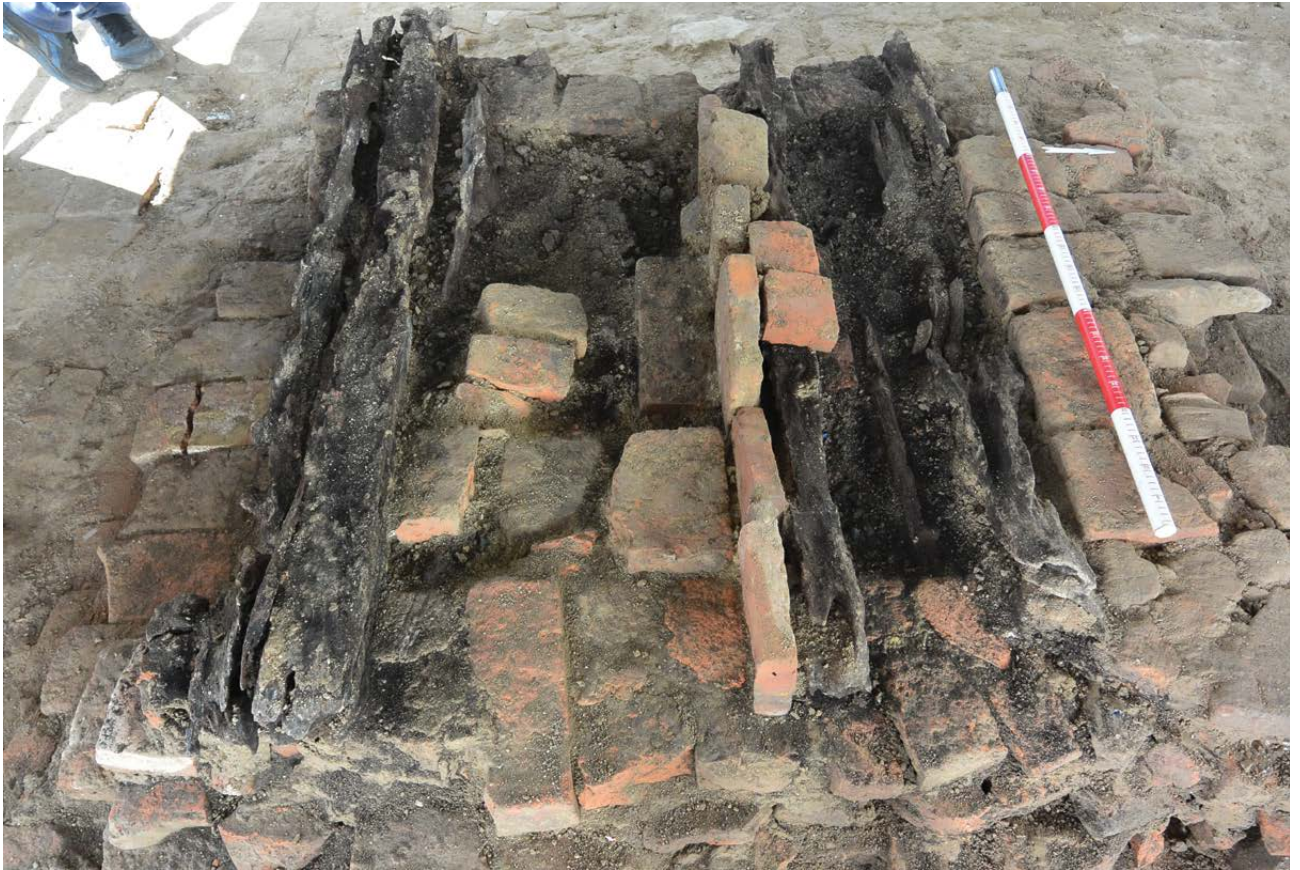
**THE CHARRED REMAINS OF FIVE WOODEN POLES**

Sixty centimetres above the base level, an 18 cm thick strata of *tsha-tshas* contained 28 kg of artefacts (context 19, MNI: 3111). Below this level five charred wooden beams were laid in a west–east direction (context 20) with beam No.1 (on the far south) showing traces of carvings. C14 dating of a sample from this hardwood beam (*shorea robusta*) indicated with a 95% probability that the tree was cut between 1445 and 1632 CE.

The central square of the mandala at level A was marked by five charred beams made of the tropical hardwood *shorea robusta*. The beams were found parallel to each other in an east–west direction, sandwiched between *tsha-tshas* (contexts 19 and 21) and covered by sand and charcoal. All beams were severely burnt and beam no. 2 exhibited traces of carvings evoking volute patterns of a pillar’s base. Due to the extreme deterioration of the objects it is difficult to ascertain if the beams were cut. The fact that the beams were severely burnt suggests that they were part of a cremation ritual (*homa*). Such a practice is mentioned by von Rospatt during one of the *mahācaitya*’s renovations<sup>1</sup> when architectural remnants were taken out of the structure and ritually cremated by community members.

Considering the symbolic significance of the burnt beams having been deposited in the core of Tashi Gomang, one might expect that they originate from another religious monument, possibly even the main stupa. Radiocarbon dating of beam no. 2 provides a range between 1445-1632 CE with a 95% probability. Therefore, the beams may originate from one of the nine documented renovations of the Svayambhūcaitya as listed by von Rospatt:<sup>2</sup> 1504 CE renovation by gTsang smyon Heruka, 1530, 1591 to 1595 and 1601 to 1604 renovations by Jayarakṣa, 1636 to 1640 renovation, 1681 to 1683, 1710, 1751 to 1758, 1814 to 1817 and the renovation attributed to Dhanasiṃha Tāmraḱār and his family in 1863-1866.<sup>3</sup>

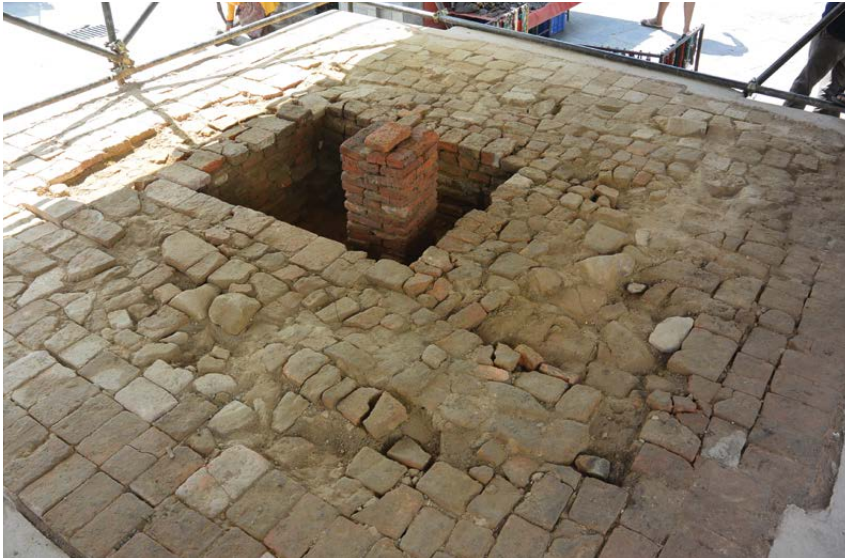
**VIEW FROM THE NORTH**  
The central shaft embedded in *tsha tshas*.  
© UNESCO | D. Andolfatto | Sep 18, 2016

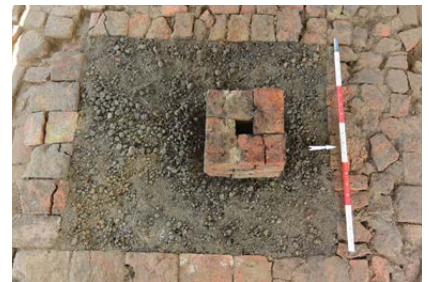
**VIEW OF LEVEL A**  
View from the east  
© UNESCO | D. Andolfatto | Sep 18, 2016

Dismantling was stopped at level A, 108 cm above the south paving level. It was determined that the brick masonry was reasonably strong enough to serve as a base for the stupa to be reconstructed.

Below the charred beams two more layers of *tsha-tshas* were excavated: context 21 contained a 32 cm thick layer and context 22 a 55 cm thick cavity filled with *tsha-tshas* accumulating to a total weight of 891,5 kg. Context 22 extended into the base of the stupa to a level of 53 cm above the south paving level. It was surprising to see that this largest void in the stupa extended quite a bit to the south, thus breaking with the otherwise symmetrical plan of the stupa. As was observed, the central shaft, the nine cavities and the L-shaped voids were all

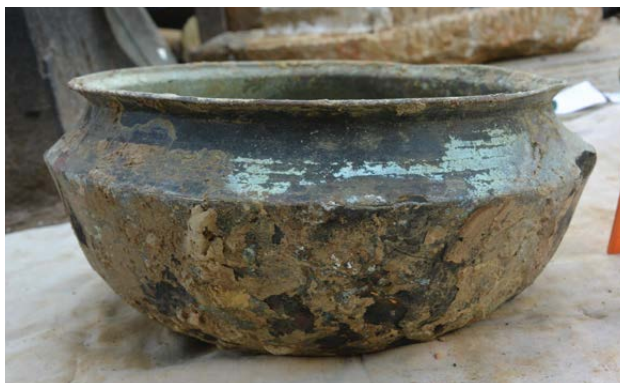
**COPPER VESSEL**  
DIA: 28 cm, height: 10 cm  
SWMOI-82,  
© Department of Archaeology/D. Bhattarai | Apr 4, 2016

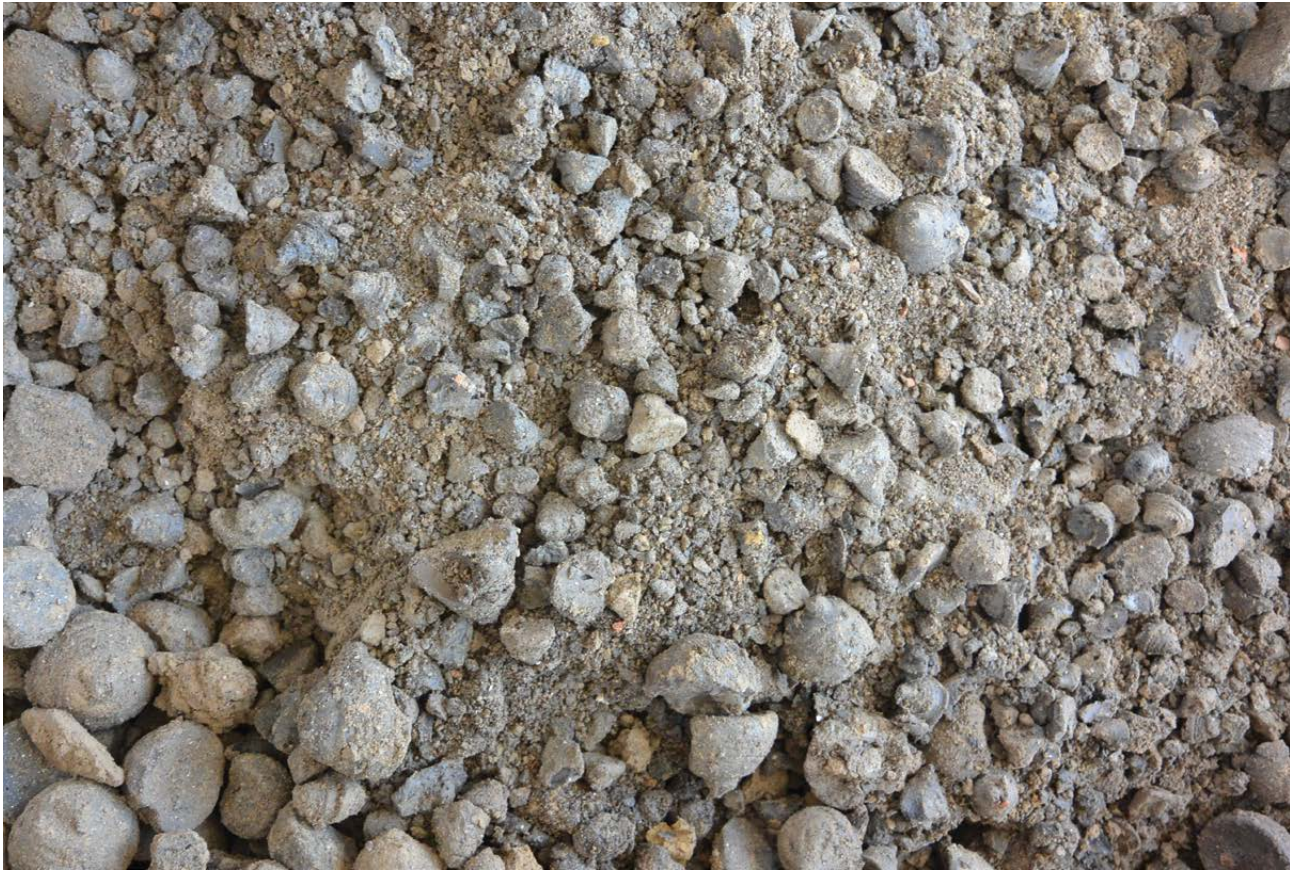
**TSHA-TSHAS FOUND BELOW THE CHARRED POLES**

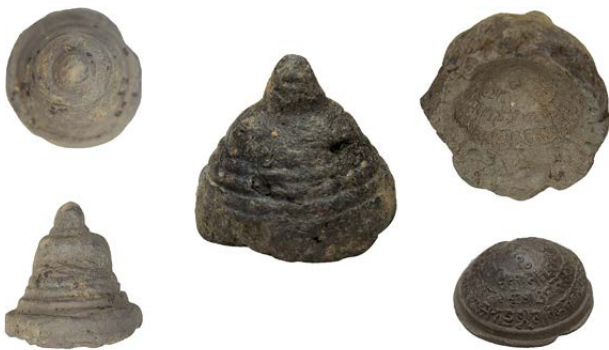
**TYPE 1 AND TYPE 4 TSHA-TSHAS**

These two types of miniature caityas were the most commonly found and are represented here in actual size. Imprinted mantras can be seen on the convex side of type 4.

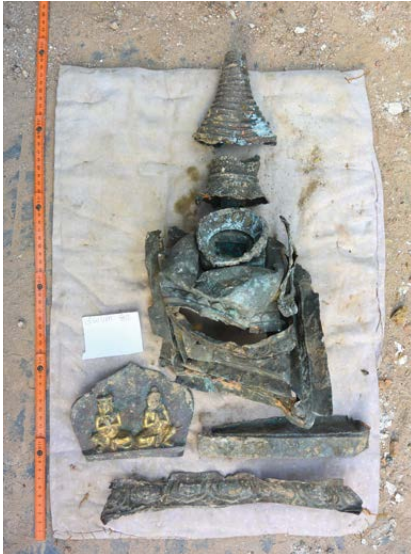
**DAMAGED COPPER REPOUSSÉ CAITYA AND AN  
INSCRIBED PLAQUE WITH TWO DONOR FIGURES**  
Early 19<sup>th</sup> century  
SWM01-80  
© UNESCO | D. Andolfatto | May 2, 2015

Metal sculptures of Tārā, Aksobhya and Dipankara Buddha were also discovered. A large copper caitya (SWMOI-080) that likely originated from the upper part of the stupa was found badly damaged. It appears that the poor condition of the object predates the earthquake of 2015. A small gilt plaque found in the rubble names two donors and bears an eroded inscription. It was nevertheless possible to read “savat 930 (or 931, or 939)” which likely refers to Nepāl Samvat and would therefore correlate to a date between 1808 and 1818 CE.

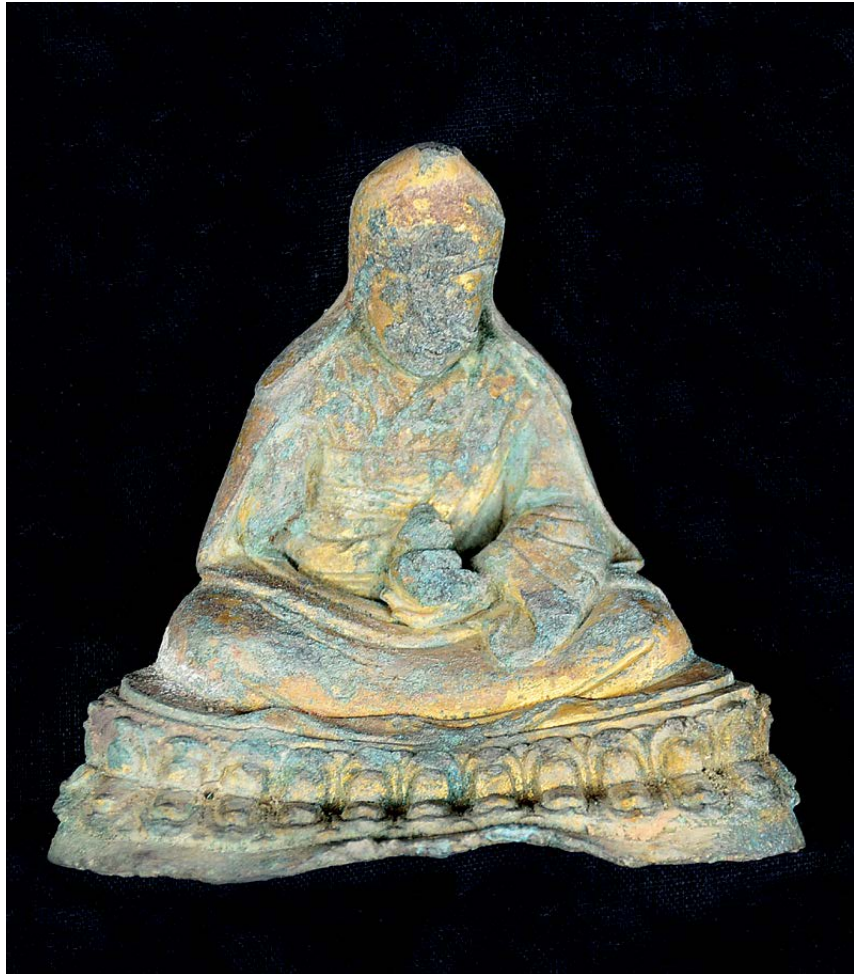
**GILT BRONZE IMAGE**  
Possibly Tsongkhapa  
SWM01-88  
© UNESCO | D. Andolfatto | Mar 15, 2016

Of particular interest is a gilt bronze image of a Tibetan master (SWMOI-088), possibly of Tibetan origin. The iconography strongly refers to Je Tsongkhapa, the 14<sup>th</sup>-15<sup>th</sup> century Tibetan founder of the Gelug school of Buddhism. It appears that the image was intentionally damaged, as indicated by the cut at the base and tool marks on the face.

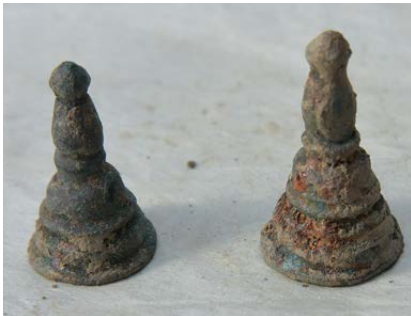
**METAL CAITYAS**  
Metal caityas that could have served as moulds  
for *tsha-tshas*  
Represented in actual size  
SWM01-384  
© UNESCO | D. Andolfatto | Sep 18, 2016

Epigraphist and researcher Kashinath Tamot has suggested that the moulds discovered during the archaeological investigations, were intentionally left in the stupa in order to allow for the making of more *tsha-tshas* during future restorations.

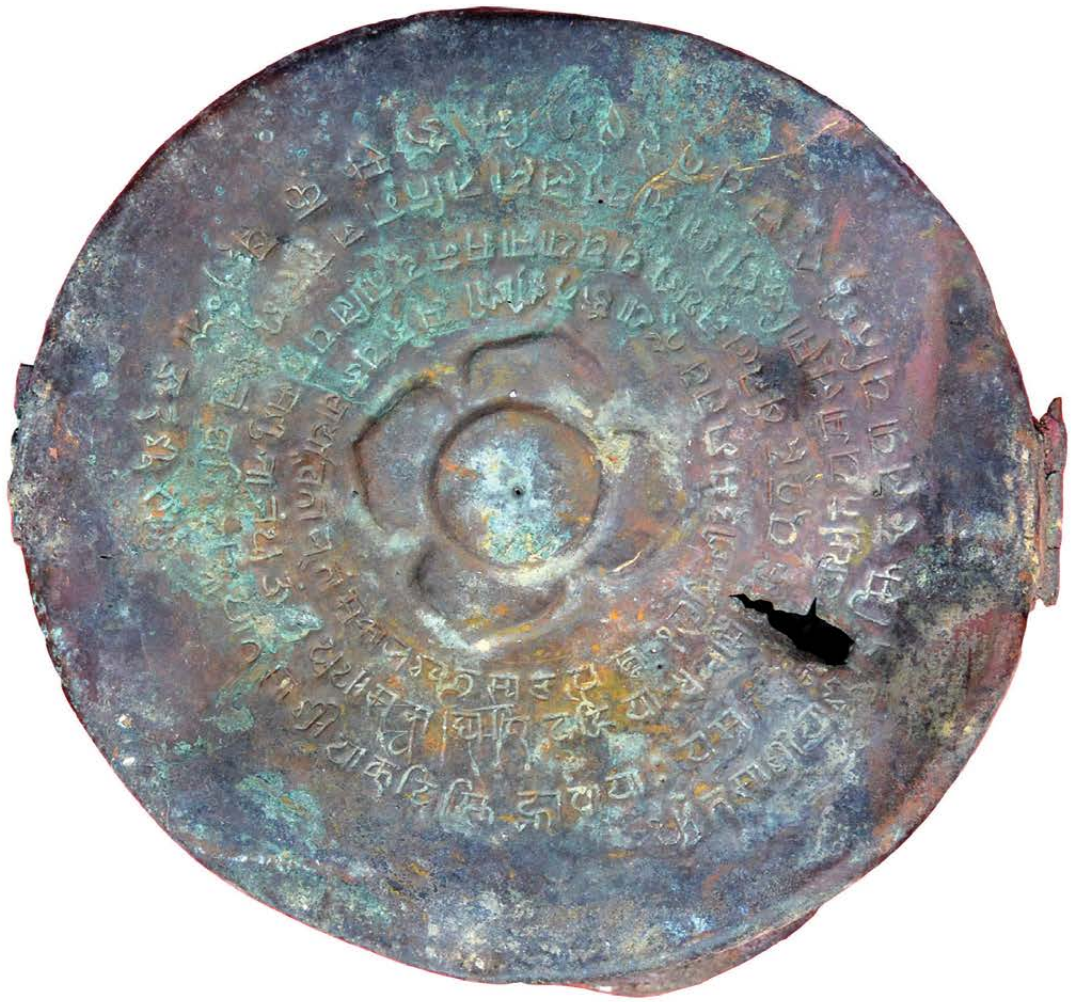
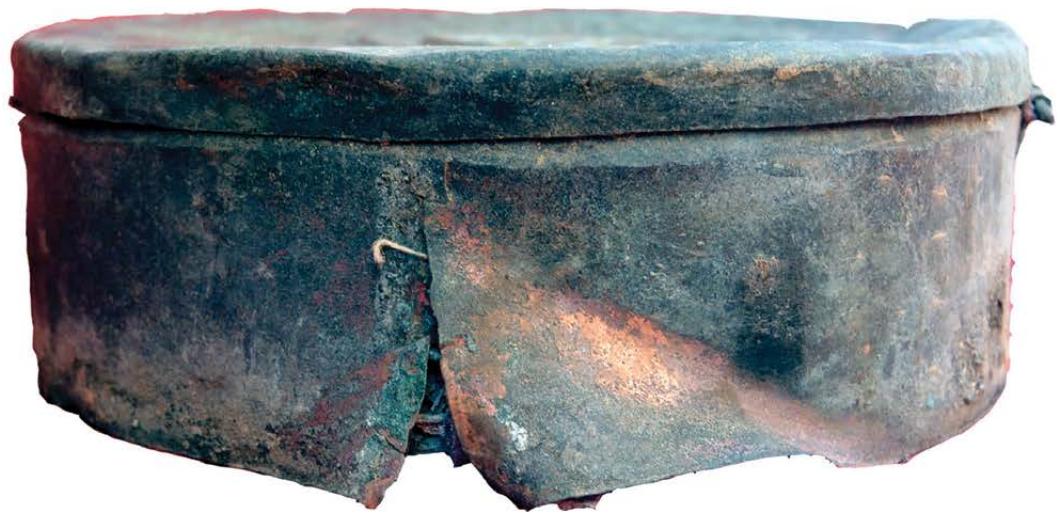
Another important dated artefact is the circular reliquary that was found on the deposit stone (SWMOI-215 and 274). The centre of the lid is ornamented with a four-petal flower pattern. Four circular lines of text in devanāgarī bear the date NS 995 (1875 CE).

DIA: 14.9 cm, H: 5.4 cm, SWMOI-215

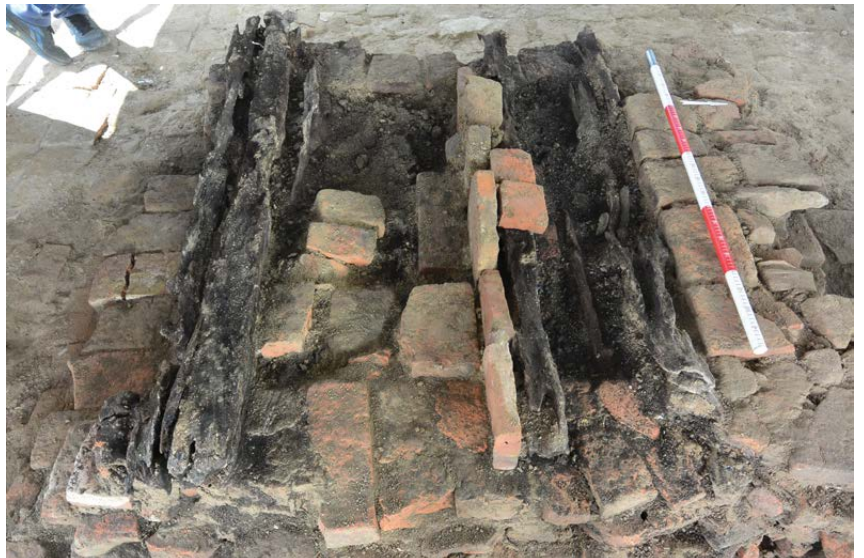
**THE CHARRED WOODEN BEAMS**

View from the east

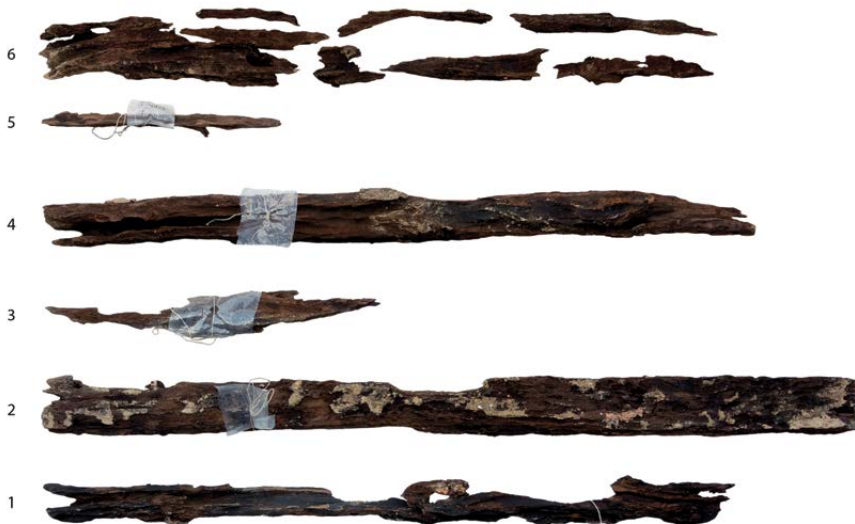
Beam No. 1: 160 x Ø 8 cm  
Beam No. 2: 160 x 10,5 x 10 cm  
Beam No. 3: 70 x 10 x 8 cm  
Beam No. 4: 140 x 10 x 8 cm  
Beam No. 5: 48 x Ø 2 cm  
Beam No. 6: 145 x 12 x 10 cm

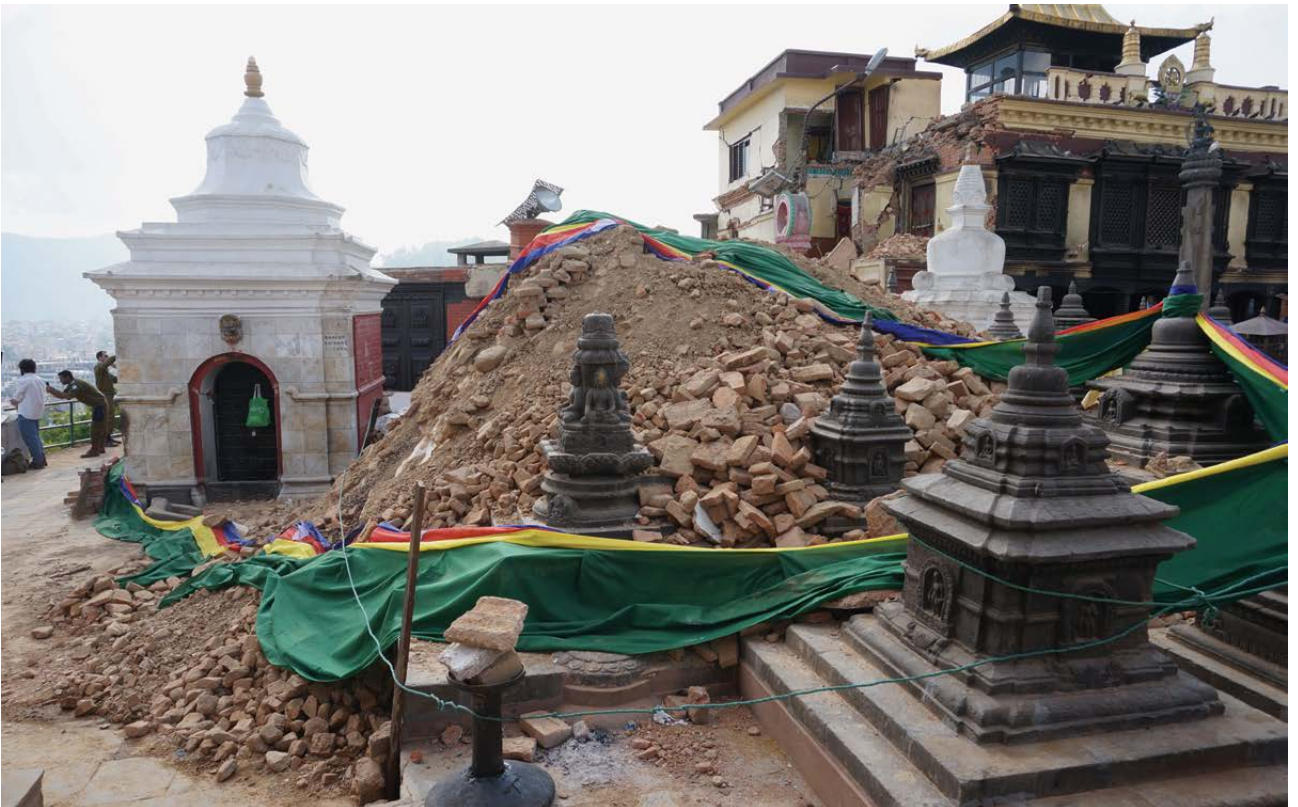
**TASHI GOMANG STUPA**

The collapsed stupa a few days after the earthquake.

The collapse of Tashi Gomang in the earthquake happened quickly and was a great surprise to all. Historically, stupas, due to their solid and squat shape have proven to be very resistant against seismic movements. Tashi Gomang was the only stupa that collapsed during the 2015 earthquake. As the archaeological excavations revealed, the main causes for the monument's collapse can be found in the poor quality of craftsmanship, the use of inferior building materials, and the fact that the design of the inner structure of the stupa did not follow traditional prescriptions and layout. Most surprisingly, the stupa was found to be missing its central wooden post (*axis mundi*) that should have extended from the base to the finial of the stupa. Such a central wooden pole not only serves an important spiritual purpose but also provides strength as a structural member. Over the past millennium the main Swayambhu caitya's central pole has been replaced on at least ten occasions. It is unclear why no such pole was present at Tashi Gomang.

Analysis of the rubble and remaining masonry revealed that the structure was built with recycled bricks of different sizes and laid with wide joints and inadequate sandy mud mortar, thus resulting in a very weak structural state. Large interior voids containing loosely placed *tsha tshas* further weakened the structural cohesion. The extremely top-heavy stone dome and stone finial, which were lacking the typical wooden post at their centre, toppled easily during the earthquake.

It is not known when the stupa was last repaired or reconstructed but it is quite evident that such repairs must have been done with little care, probably in a hurry, with little expertise in traditional construction methods and executed with extremely poor craftsmanship.
