# The Restoration of Mangal Bahudvara Caitya. A Tashi Gomang Stupa

THE RESTORATION OF  
MANGAL BAHUDVARA CAITYA  
TASHI GOMANG STUPA

SVAYAMBHU, KATHMANDU VALLEY WORLD HERITAGE SITE

EDITED BY DAVID C. ANDOLFATTO AND THOMAS SCHROM  
WITH CONTRIBUTIONS BY NUTANDHAR SHARMA

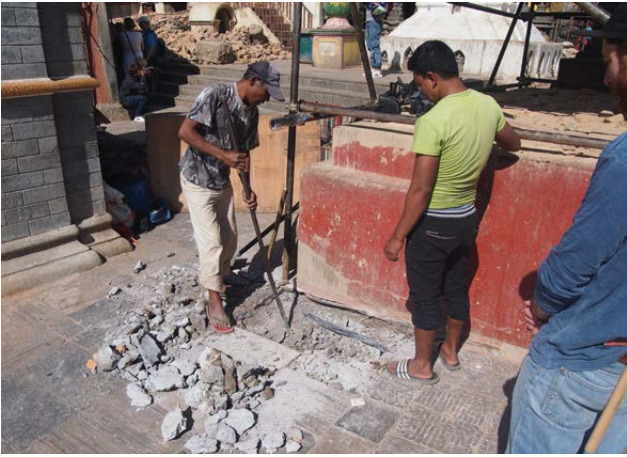
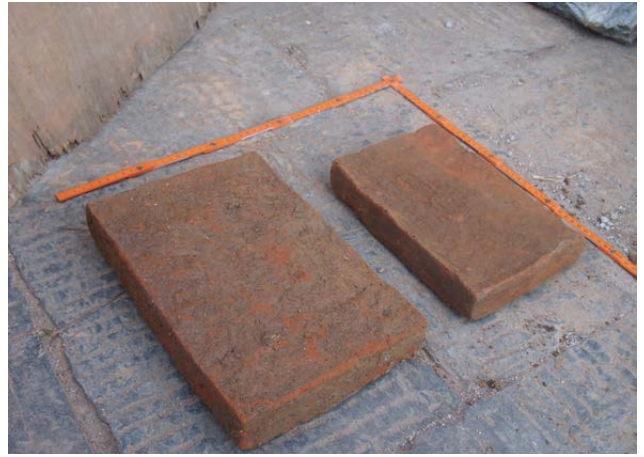
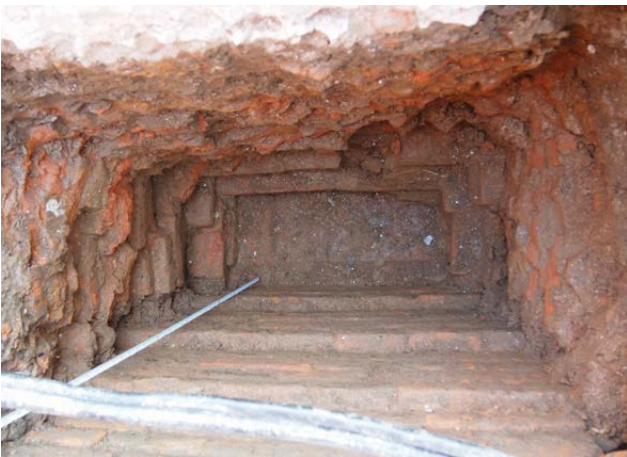
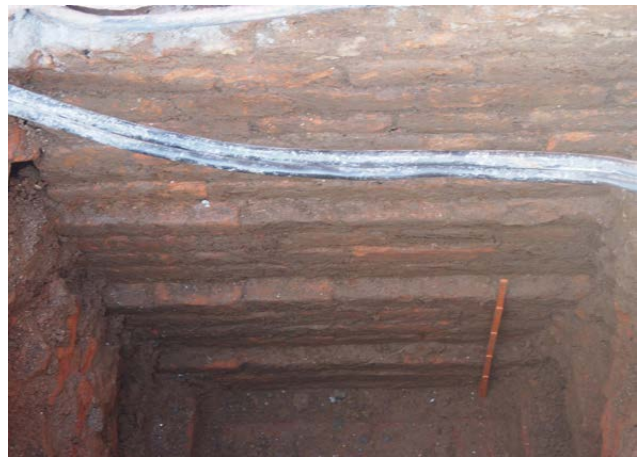
**VIEWS OF THE INSPECTION TRENCH**

The foundation, consisting of tightly laid brick in mud mortar, was found to be in very good condition.

On November 11, 2016, a test pit was dug near the south-west corner of the monument in order to investigate the condition of the foundations. Representatives of the religious community requested that the excavation be stopped when the digging was at a depth of 130 cm, even though the bottom of the foundation had not been reached. The observed construction pattern shows the typical stepped foundation at regular intervals and tightly-laid courses of brick in mud mortar. The excellent quality of construction here was found to be completely different from what was seen in the upper structure. The small size of the hand-made bricks used is typical of structures dating to the 17<sup>th</sup> century or possibly even earlier.

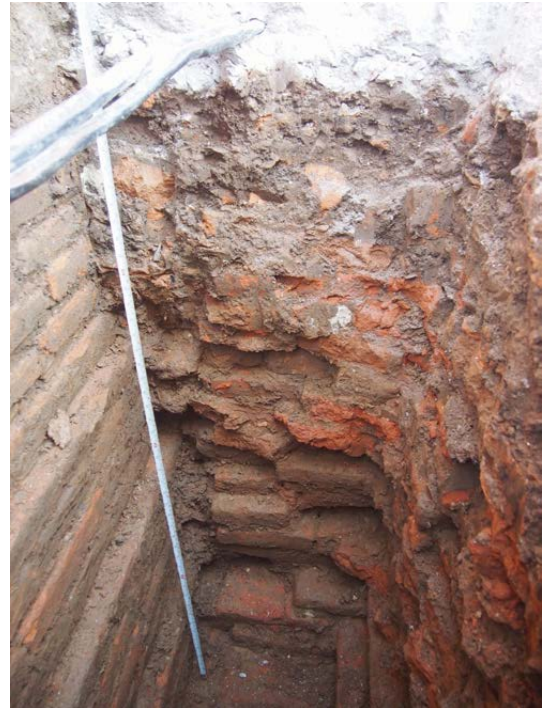
CROSS-SECTION DRAWING AND VIEW OF THE INSPECTION TRENCH  
 © UNESCO | D. Andolfatto and T. Schrom | Nov 11, 2016

As described in detail in the chapter on archaeology, the remnants of the stupa were carefully disassembled and checked for finds, and materials not usable for the reconstruction were discarded. Brick rubble was removed down to the square base of the stupa, approximately 108 cm above the stupa's southern paving level. At this level, stable brick masonry was identified and deemed strong enough to support the weight of the reconstructed stupa. Less than 10% of the caitya's bricks were determined to be reusable for the reconstruction.

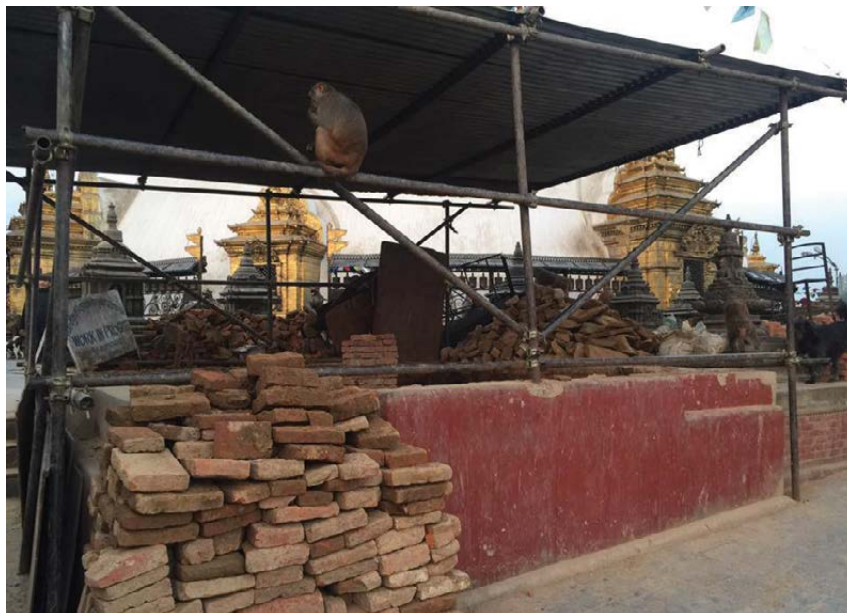
**THE RECONSTRUCTED BASE OF THE STUPA**

The base was completed with newly made brick laid in a lime and brick dust (*surkhe*) mortar. The central cavity was rebuilt at the center

In November 2017 SFMC identified a group of qualified craftsmen from Bhaktapur to take on the rebuilding of the masonry structure from the ground up. These masons had ample experience with similar restoration projects and work started in earnest in December. Interestingly, the masons did not trust the strength and stability of the stupa's brick base that had been left untouched since the conclusion of the archaeological excavations. In agreement with representatives of SFMC the brick base was further dismantled and a new perimeter wall was erected around the structure. This was followed by the pouring of a concrete pad foundation with the intent to provide an even stronger base to support the rebuilt superstructure.

Newly manufactured bricks were shaped by hand to achieve the necessary mouldings following historic examples. As mentioned, it was decided early on to not use the traditional mud mortar in the brick masonry. Despite the fact that mud has been

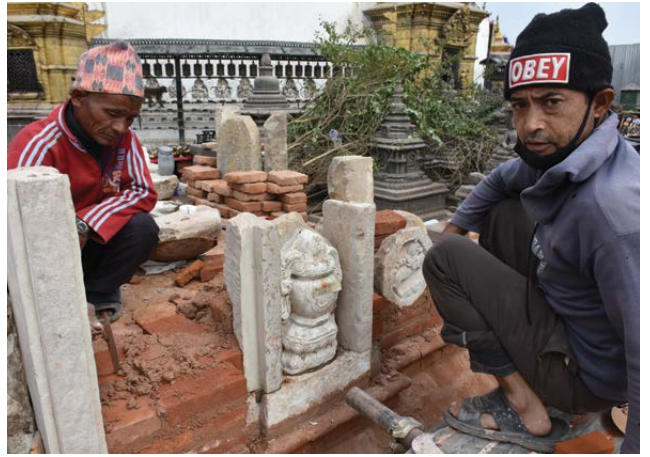
**INSTALLATION OF SCULPTURES AND NICHES**

Setting up of the first level of stone sculptures and the frames of niches. The base level of the four L-shaped cavities can be seen in the centre.

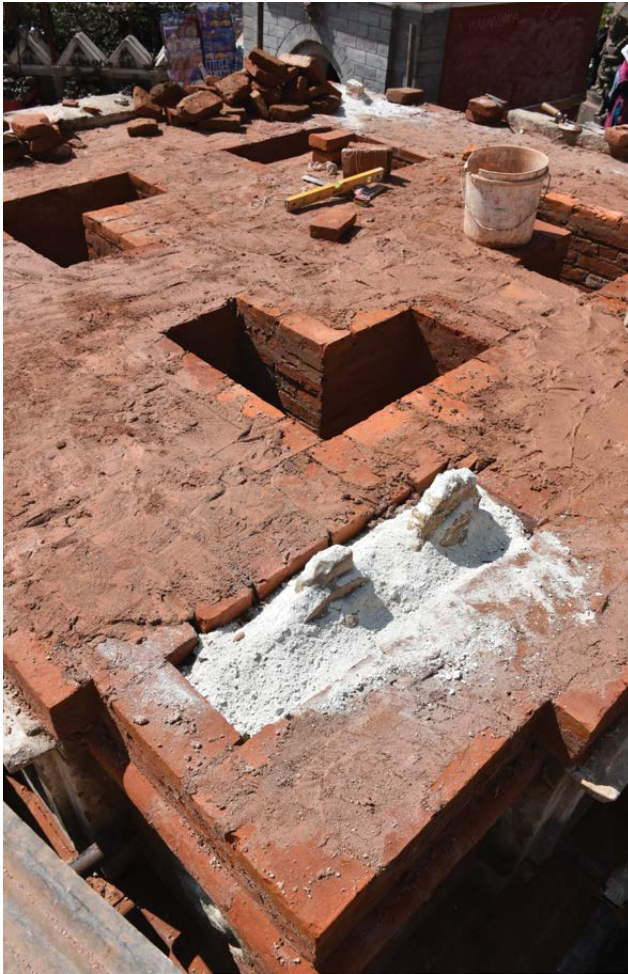
#### THE RECONSTRUCTED BASE OF THE STUPA

Two terracotta sculptures were inserted in a cavity exactly where they were found during the excavations.  
© UNESCO | D. Andolfatto | Feb 21, 2017

The lowest tier of the caitya was rebuilt according to the excavation drawings with one rectangular cavity and four L-shaped voids that were later filled with *tsha tshas* and terracotta statues placed in the same positions as they had been found in during the dismantling. It is interesting to note that the entire monument was rebuilt with new bricks as most of the original bricks which had been conserved for reuse had accidentally been used in another project.

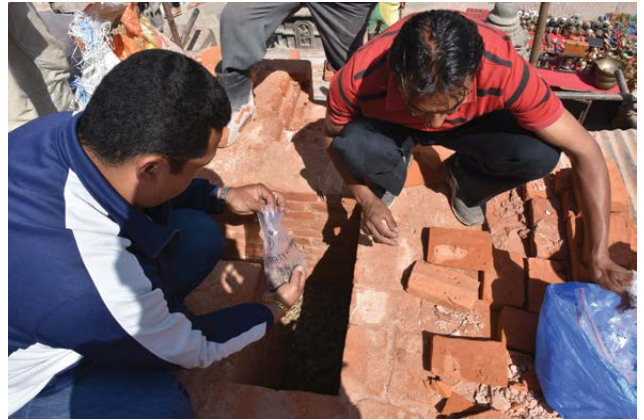
#### L-SHAPED CAVITIES

New stone slabs are being cut to firmly cover the cavities.  
© UNESCO | D. Andolfatto | Mar 2, 2017

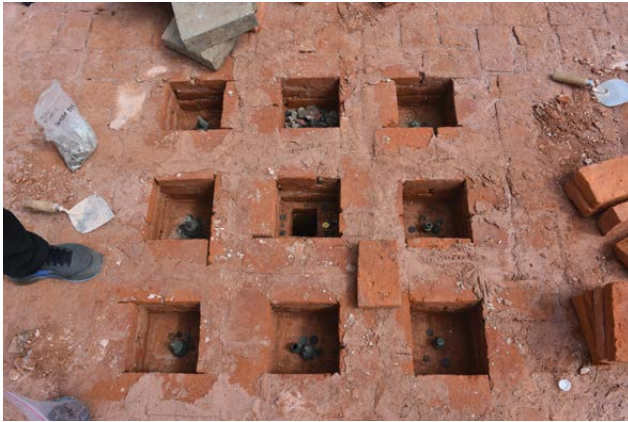
#### NINE CAVITIES

Closing of the nine cavities with stone slabs.

Reconstruction of the nine cavities followed precisely the documented excavation drawings. The small objects salvaged earlier had been carefully numbered and were stored; they were reinserted exactly where they had been found.

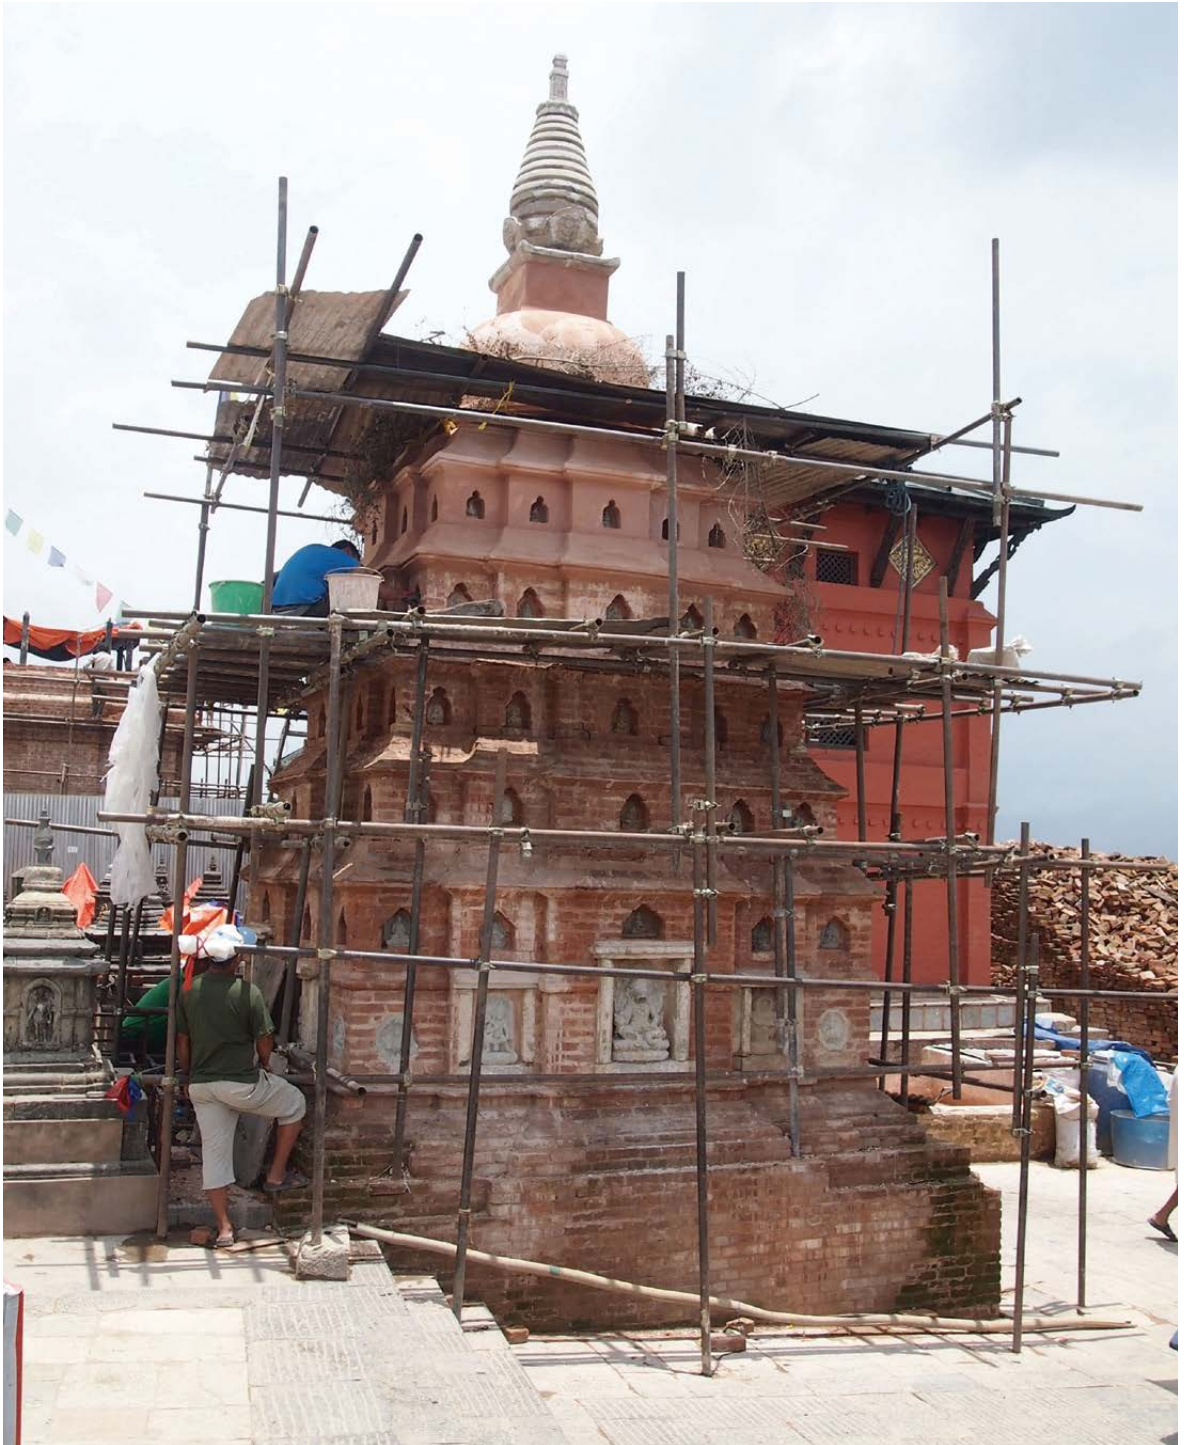
**TASHI GOMANG, NORTH ELEVATION**

The pink-coloured plaster is a mixture of brick dust and lime, and the original stone finial was repaired and reinstalled.

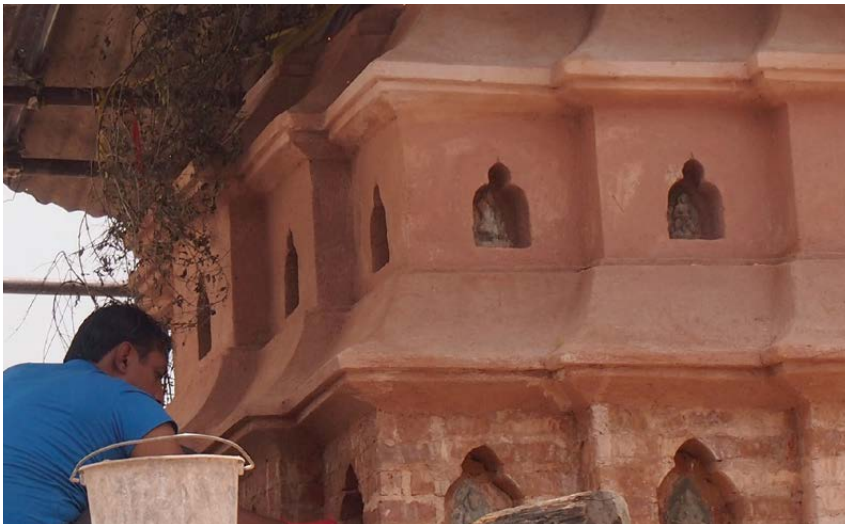
**OBJECT 166 ON LEVEL 6, FACING NORTH**  
 Detail of a typical niche after application of the first layer of lime and brick dust plaster.  
 © UNESCO | T. Schrom | Jul 3, 2017

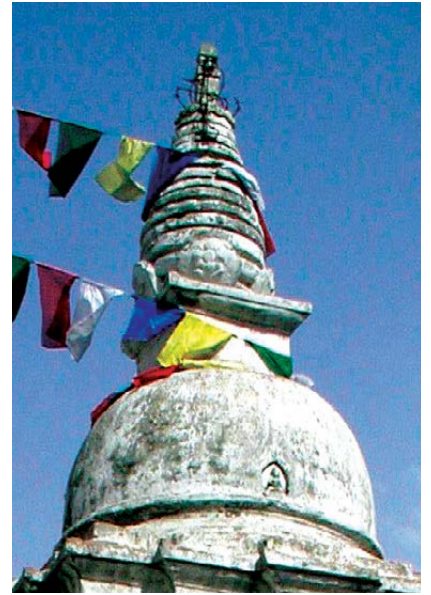
**THE FINIAL**  
*top:* The original spire was poorly crafted, displaying unevenly shaped rings. At some point, probably in the 1934 earthquake, the finial had broken into two parts and was mended with iron clamps.  
 Photograph by Manik Bajracharya, courtesy of the Lotus Research Center | ca.1995

*above:* The original finial was mended and partly reshaped in order to achieve a more uniform and balanced appearance.  
 © UNESCO | D. Andolfatto | Aug 11, 2017

Originally, the finial was made of simple stone which had been whitewashed. During the reconstruction, the damage to the stone was filled in with a composite repairing material and then remounted. At this stage, a generous donor came forward, offering to pay for a new gilt-copper cladding for the finial; it is this that is now seen atop the restored Tashi Gomang.

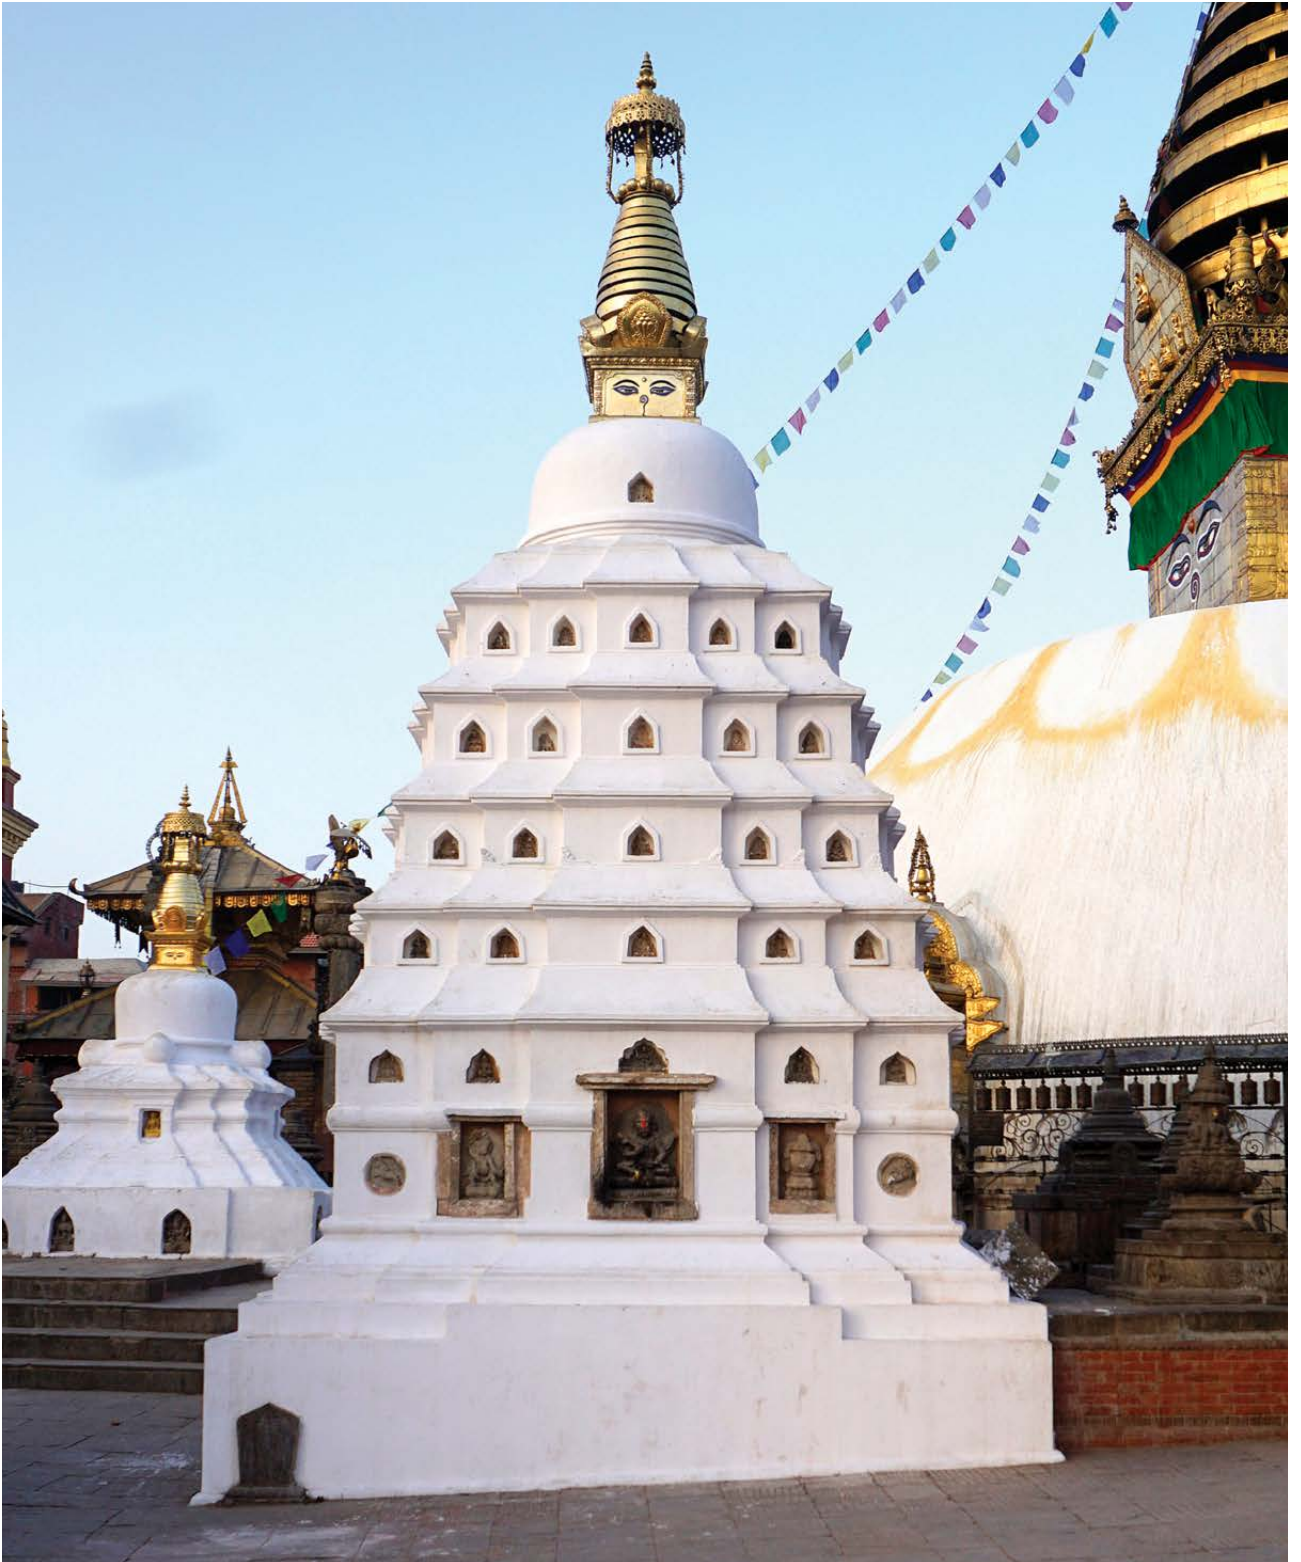
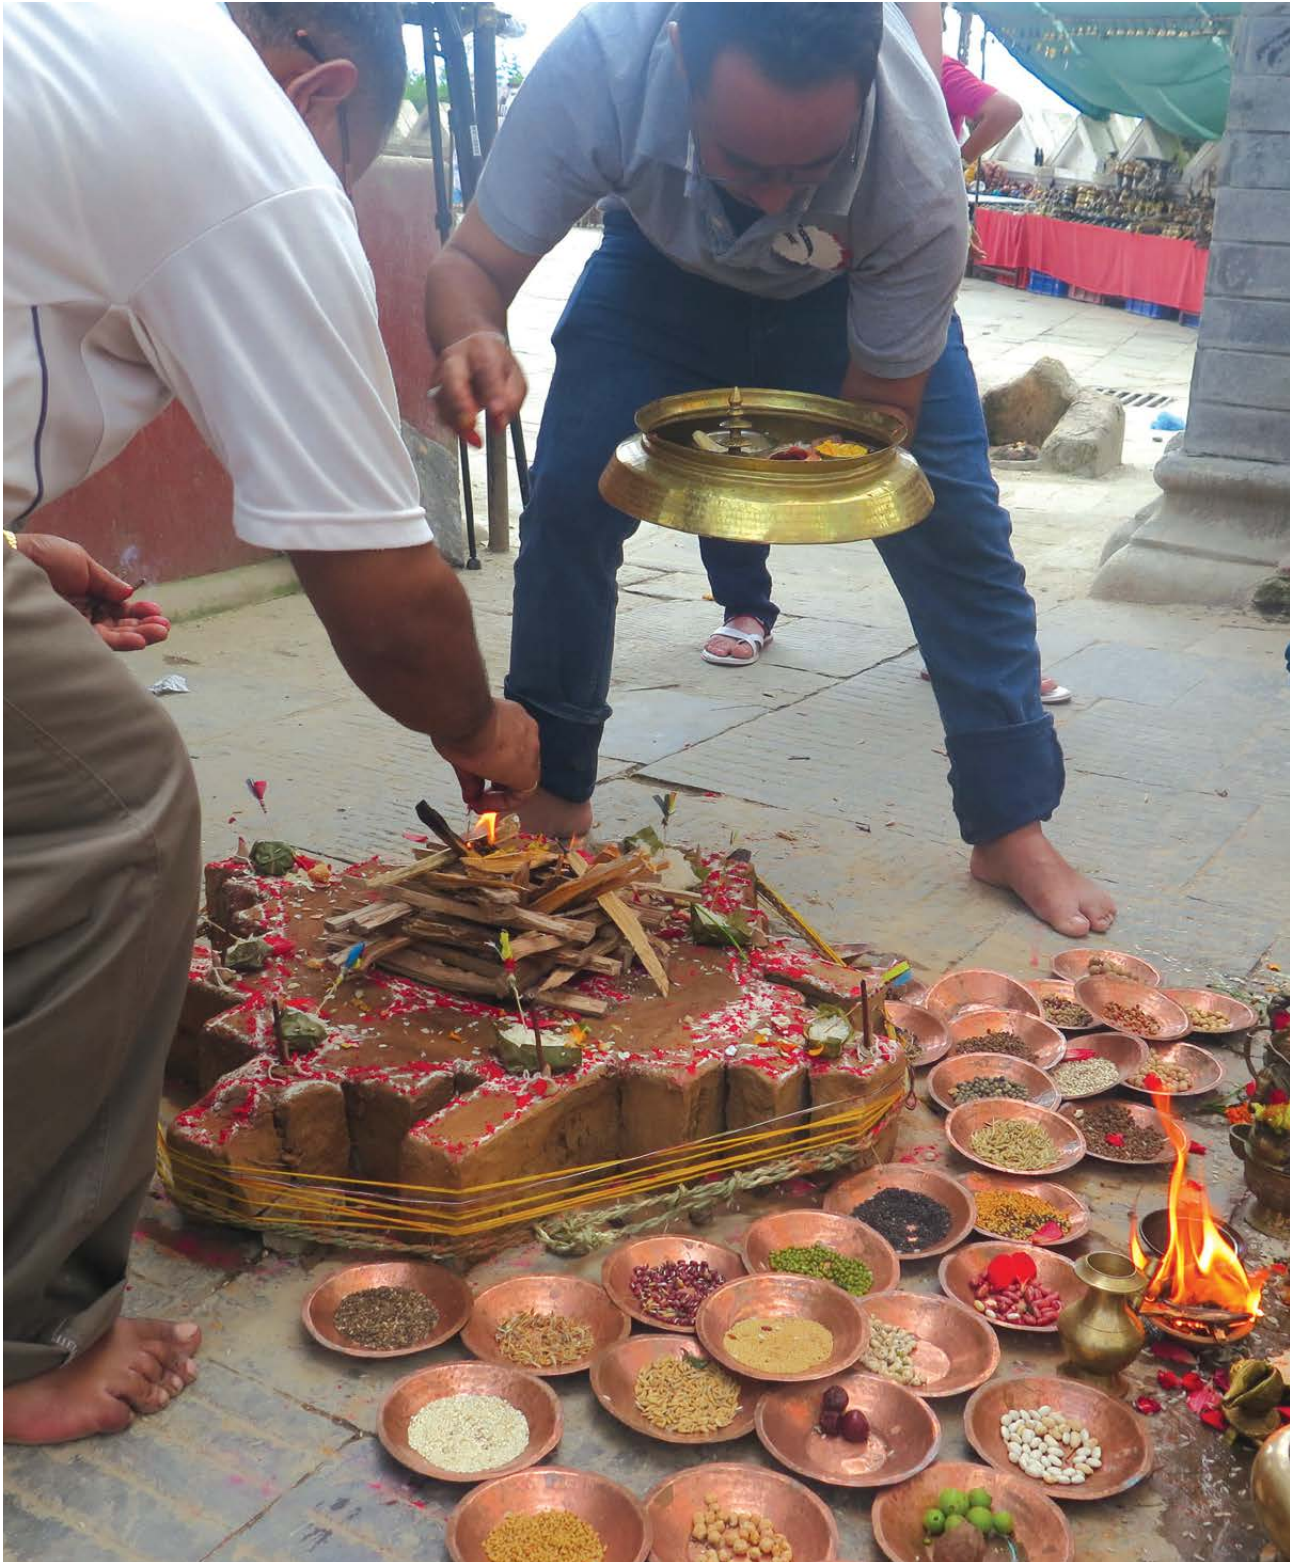
**TASHI GOMANG STUPA, SOUTH ELEVATION**  
 Comparison of the original drawing for reconstruction (left half) and the actually built stupa (right half).  
 © UNESCO | T. Schrom | 2018

**TASHI GOMANG STUPA, SOUTH ELEVATION**  
 The caiya was whitewashed and received a gilt metal clad finial, contributed by a private donor.  
 © UNESCO | T. Schrom | Jan 25, 2021
