# The Restoration of Mangal Bahudvara Caitya. A Tashi Gomang Stupa

THE RESTORATION OF  
MANGAL BAHUDVARA CAITYA  
TASHI GOMANG STUPA

SVAYAMBHU, KATHMANDU VALLEY WORLD HERITAGE SITE

EDITED BY DAVID C. ANDOLFATTO AND THOMAS SCHROM  
WITH CONTRIBUTIONS BY NUTANDHAR SHARMA

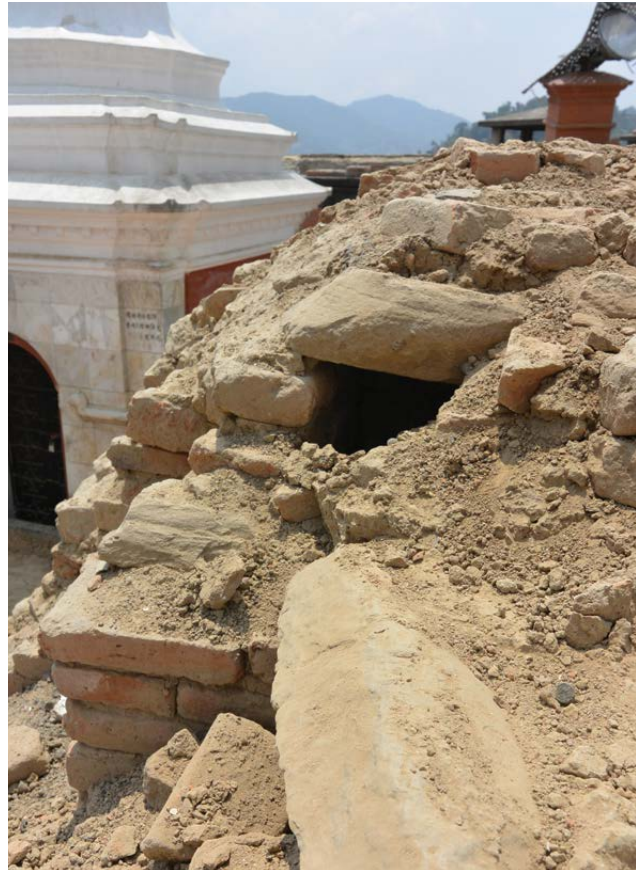
**SOUTH-EAST CORNER**

This image illustrates the unstable condition of the monument. At the center is a cavity that held numerous *tsbas*.

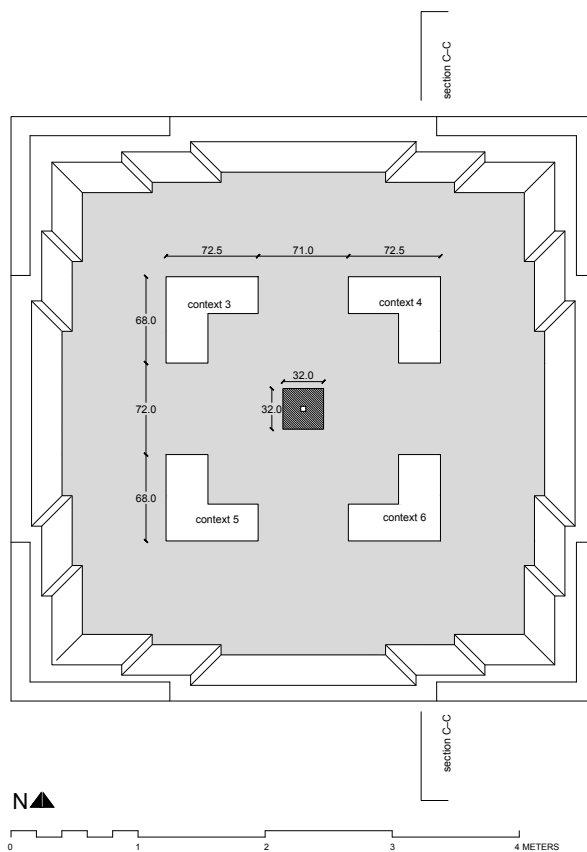
#### CENTRAL SHAFT AND L-SHAPED VOIDS

This view from the south-east shows an L-shaped void that was filled with miniature clay stupas. Many different shapes and sizes of bricks can be observed with unusually wide mortar joints that often do not line up due to the different thicknesses of the bricks. In many places brick rubble was used to fill in the masonry. All this indicates that we do not see an original construction but rather the results of poor repairwork. It is quite possible that the caitya was rebuilt in haste with recycled materials after it was damaged by a previous earthquake.

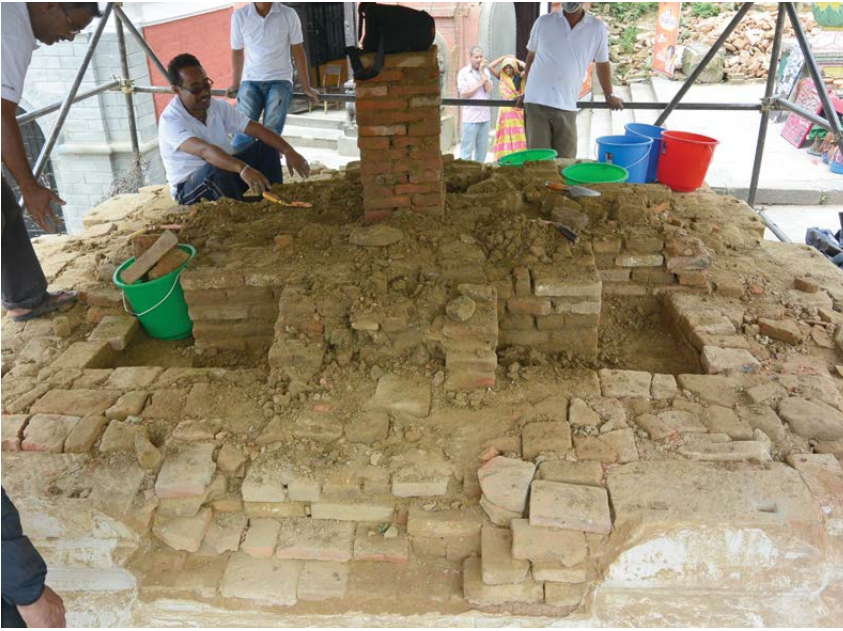
**THE CENTRAL SHAFT AND L-SHAPED VOIDS**  
View from the east  
© UNESCO | D. Andolfatto | Aug 29, 2016

Four L-shaped cavities with an average height of 100 cm were found near the four corners. The cavities were covered with large stone slabs and bricks. The north-west, south-east and south-west cavities were completely filled with *tsha-tshas*, while the one on the north-east had partly collapsed in the earthquake. At the centre, the square brick core has wall projections facing the cardinal direction. The arrangement thus creates an architectural mandala, enshrined within the stupa.

The core of the masonry contains a vertical shaft. This could be a merely symbolic structure or it might have had a practical application. Dominique Baudais of INRAP (France) suggests that the central shaft could have served as a measuring point, helping the masons to achieve the regular symmetrical shape of the caitya. A wooden stick could have been placed in the small hole with a string attached to it. Knots on the string would have allowed the measurement of uniform distances in all four directions.

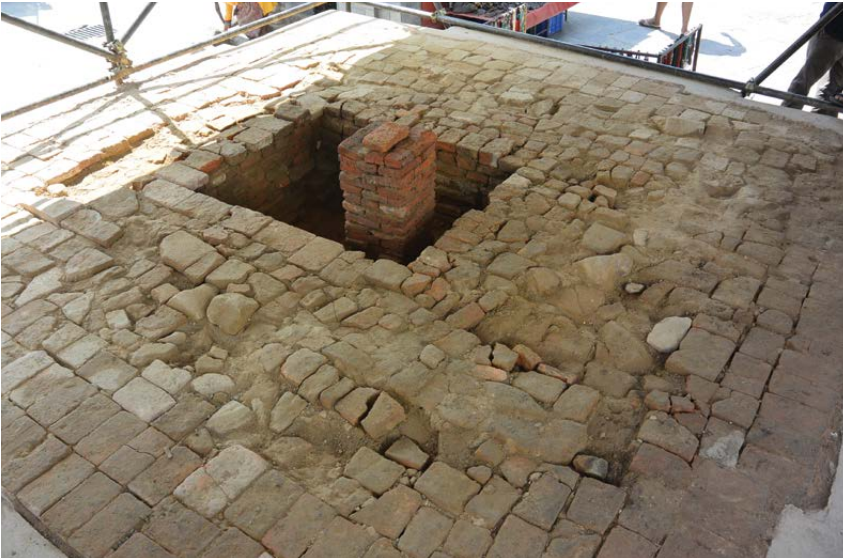
**VIEW FROM THE NORTH**  
The central shaft embedded in *tsha tshas*.  
© UNESCO | D. Andolfatto | Sep 18, 2016

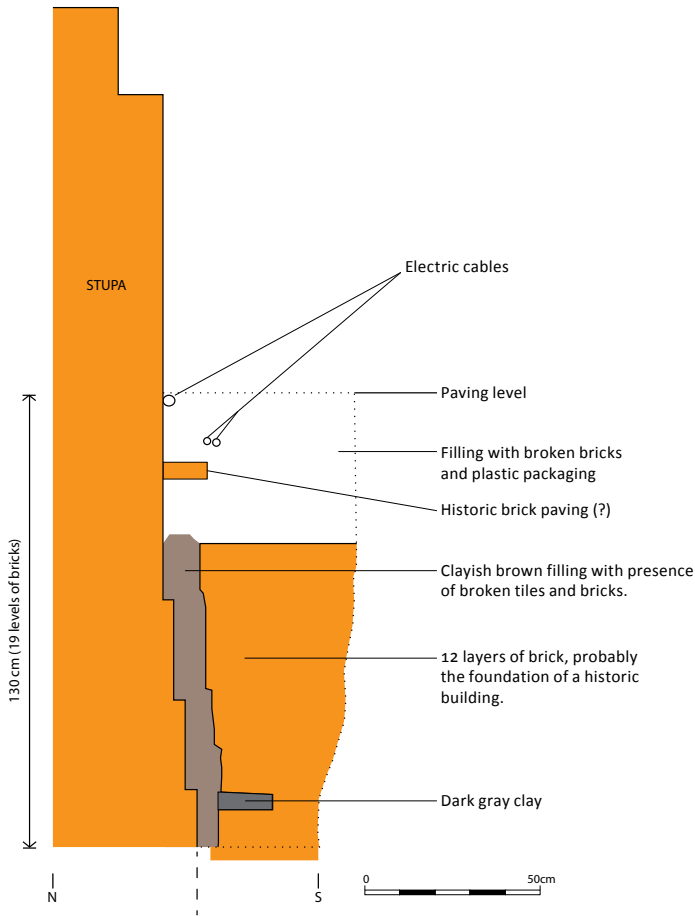
CROSS-SECTION DRAWING AND VIEW OF THE INSPECTION TRENCH  
 © UNESCO | D. Andolfatto and T. Schrom | Nov 11, 2016

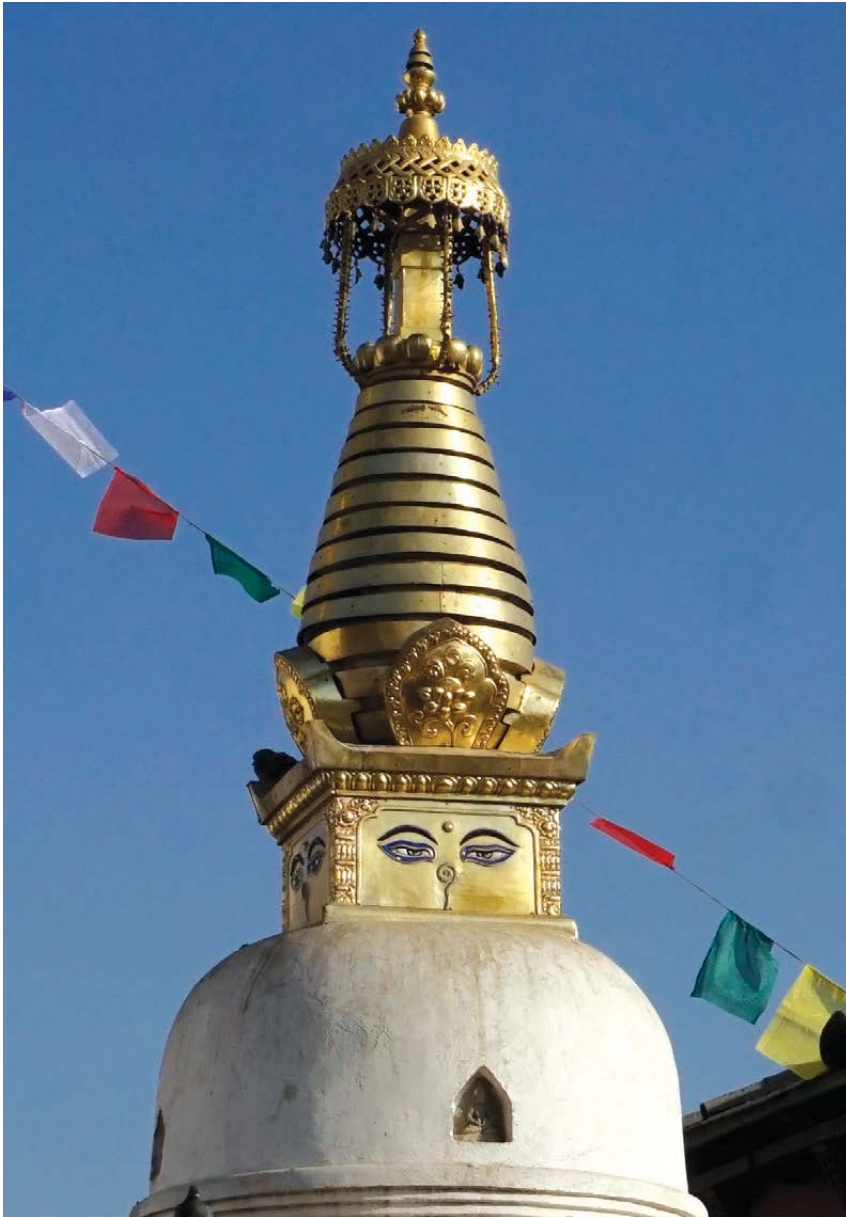
**THE COMPLETED GILT-COPPER FINIAL**  
 © UNESCO | T. Schrom | Dec 29, 2020

Originally, the finial was made of simple stone which had been whitewashed. During the reconstruction, the damage to the stone was filled in with a composite repairing material and then remounted. At this stage, a generous donor came forward, offering to pay for a new gilt-copper cladding for the finial; it is this that is now seen atop the restored Tashi Gomang.

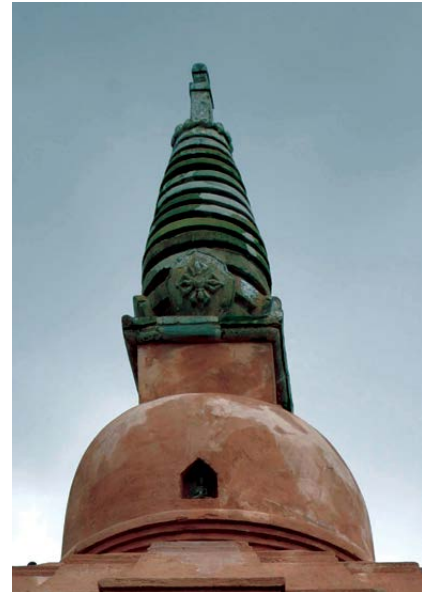
**THE FINIAL**  
*top:* The original spire was poorly crafted, displaying unevenly shaped rings. At some point, probably in the 1934 earthquake, the finial had broken into two parts and was mended with iron clamps.  
 Photograph by Manik Bajracharya, courtesy of the Lotus Research Center | ca.1995

*above:* The original finial was mended and partly reshaped in order to achieve a more uniform and balanced appearance.  
 © UNESCO | D. Andolfatto | Aug 11, 2017

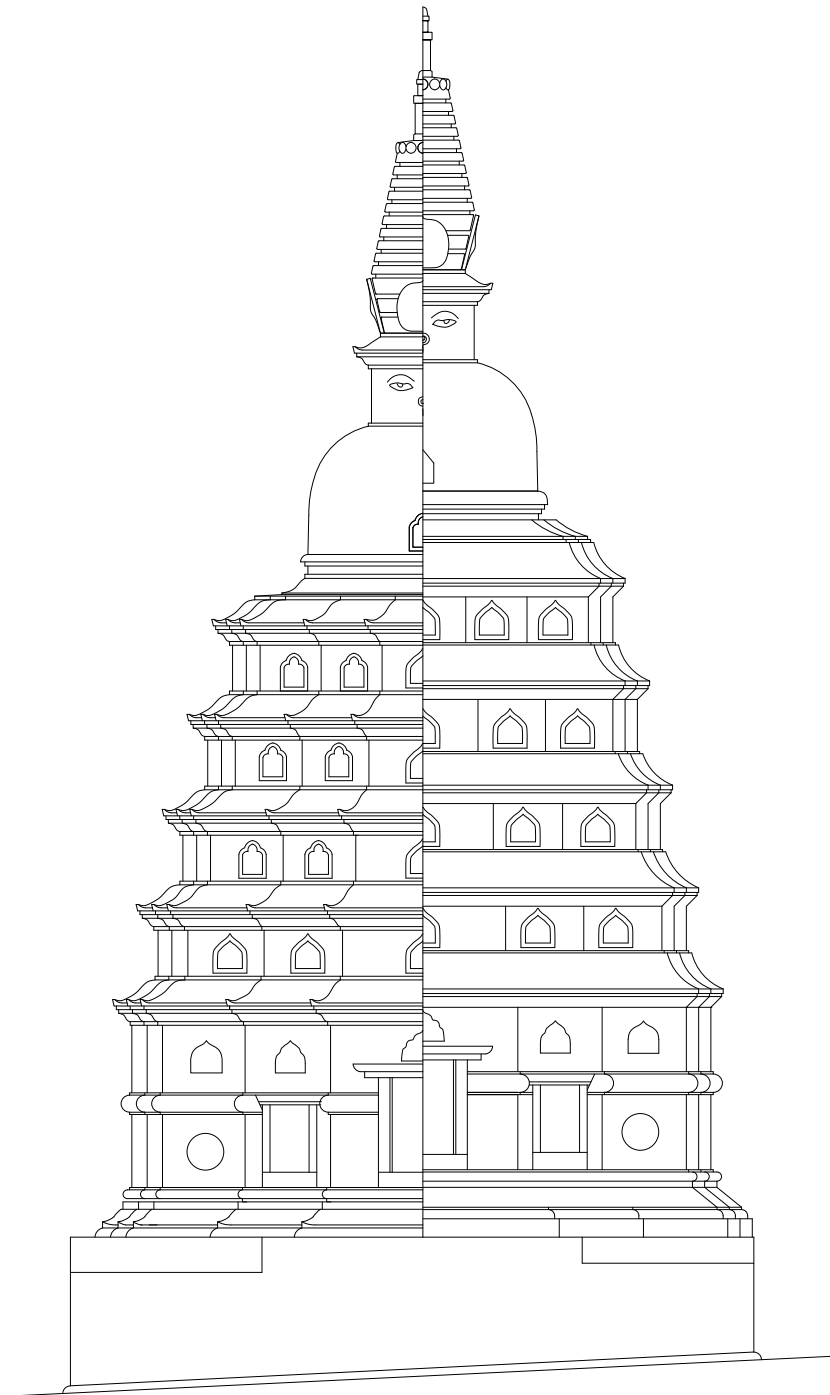
**TASHI GOMANG STUPA, SOUTH ELEVATION**  
 Comparison of the original drawing for reconstruction (left half) and the actually built stupa (right half).  
 © UNESCO | T. Schrom | 2018
