Assessing and investigating Swayambhūnath after the “Gorkha Earthquake” of 2015

Assessing and investigating Svayambhū after the “Gorkha Earthquake” of 2015

In the aftermath of the Gorkha earthquake of 25 April 2015, archaeological and architectural work has been conducted at the holy site of Svayambhū (Monument Zone of Kathmandu Valley World Heritage Site). Being the focal point of a large number of devotees, a prompt and adequate emergency response was needed to secure and protect the cultural and architectural heritage of the temples, houses, shrines and artifacts. Two methods were practised: a post-disaster archaeological investigation and an architectural inventory and survey. The former resulted in an archaeological analysis of a stūpa, and the latter was conducted to produce an up-to-date map of all buildings in their current state and an inventory of each structure with relevant diagnosis, photographs and situation outlines.

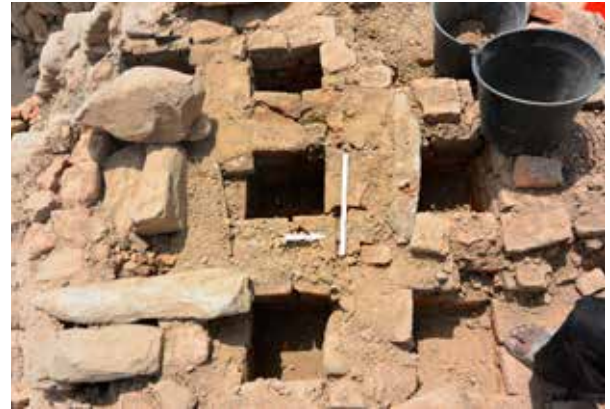
The core of Maṅgal Bahudvāra Caitya Stupa, as the excavation revealed, is a square tower of bricks punctuated at a certain level by nine hollow boxes

Fig 8. Top view of Tashi Gomang Stūpa after archaeological cleaning. Large stones were covering nine recesses. © D. Andolfatto/UNESCO Kathmandu

(Fig. 7 and 8)*. The central box is that of the Mount Meru or “axis mundi”. It has a narrow cavity to the centre that goes 2.30 meters deep. Miniature clay images representing *stūpas* or deities, known as *tsha-tshas* in Tibetan, were found placed in small numbers in the nine depressions. Massive quantities of these votive objects were found in the masonry enclosing the brick core. Some of the *tech-tshas* represent Buddhist gods and goddesses (Fig. 9). Coins of different origins were also discovered: British Indian quarter annas of 1862 CE, silver rupees of early 18th century Mughal Emperors. This very unique stūpa must have been built (or rebuilt) during the 1860’s or 1870’s CE, as H. A. Oldfield, who describes Svayambhū between 1850 and 1863 CE does not mention it. A more in-depth study of the objects kept at the Maṅgal Bahudvāra Caitya Stūpa will provide more information regarding the multi-cultural environment of the 19th century CE Svayambhū.
