Assessing and investigating Swayambhūnath after the “Gorkha Earthquake” of 2015

Assessing and investigating Svayambhū after the “Gorkha Earthquake” of 2015

In the aftermath of the Gorkha earthquake of 25 April 2015, archaeological and architectural work has been conducted at the holy site of Svayambhū (Monument Zone of Kathmandu Valley World Heritage Site). Being the focal point of a large number of devotees, a prompt and adequate emergency response was needed to secure and protect the cultural and architectural heritage of the temples, houses, shrines and artifacts. Two methods were practised: a post-disaster archaeological investigation and an architectural inventory and survey. The former resulted in an archaeological analysis of a stūpa, and the latter was conducted to produce an up-to-date map of all buildings in their current state and an inventory of each structure with relevant diagnosis, photographs and situation outlines.

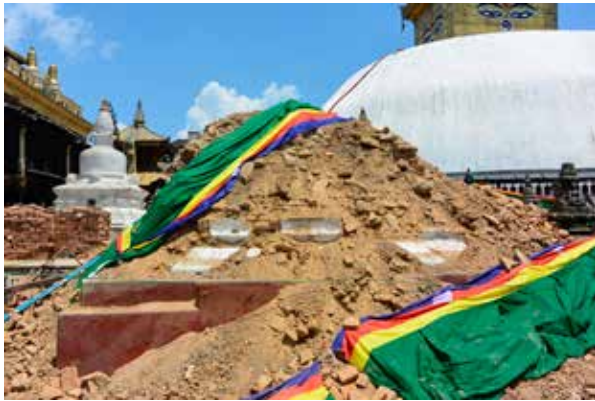
The core of Maṅgal Bahudvāra Caitya Stupa, as the excavation revealed, is a square tower of bricks punctuated at a certain level by nine hollow boxes

Fig 7. Tashi Gomang Stūpa shortly after its collapse. 1st May 2015. © D. Andolfatto/UNESCO Kathmandu

(Fig. 7 and 8)*. The central box is that of the Mount Meru or “axis mundi”. It has a narrow cavity to the centre that goes 2.30 meters deep. Miniature clay images representing *stūpas* or deities, known as *tsha-tshas* in Tibetan, were found placed in small numbers in the nine depressions. Massive quantities of these votive objects were found in the masonry enclosing the brick core. Some of the *tech-tshas* represent Buddhist gods and goddesses (Fig. 9). Coins of different origins were also discovered: British Indian quarter annas of 1862 CE, silver rupees of early 18th century Mughal Emperors. This very unique stūpa must have been built (or rebuilt) during the 1860’s or 1870’s CE, as H. A. Oldfield, who describes Svayambhū between 1850 and 1863 CE does not mention it. A more in-depth study of the objects kept at the Maṅgal Bahudvāra Caitya Stūpa will provide more information regarding the multi-cultural environment of the 19th century CE Svayambhū.

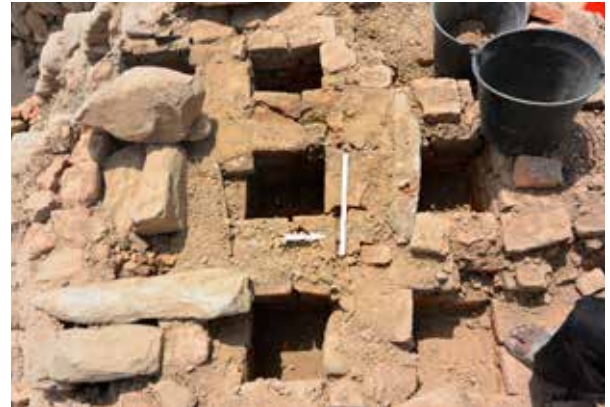
Fig 8. Top view of Tashi Gomang Stūpa after archaeological cleaning. Large stones were covering nine recesses. © D. Andolfatto/UNESCO Kathmandu
