Assessing and investigating Swayambhūnath after the “Gorkha Earthquake” of 2015

David Cornélius Andolfatto, Ludovic Dusuzeau, Pierre Gérard-Bendélé

In the aftermath of the Gorkha earthquake of 25 April 2015, archaeological and architectural work has been conducted at the holy site of Svayambhū (Monument Zone of Kathmandu Valley World Heritage Site). Being the focal point of a large number of devotees, a prompt and adequate emergency response was needed to secure and protect the cultural and architectural heritage of the temples, houses, shrines and artifacts. Two methods were practised: a post-disaster archaeological investigation and an architectural inventory and survey. The former resulted in an archaeological analysis of a stūpa, and the latter was conducted to produce an up-to-date map of all buildings in their current state and an inventory of each structure with relevant diagnosis, photographs and situation outlines.

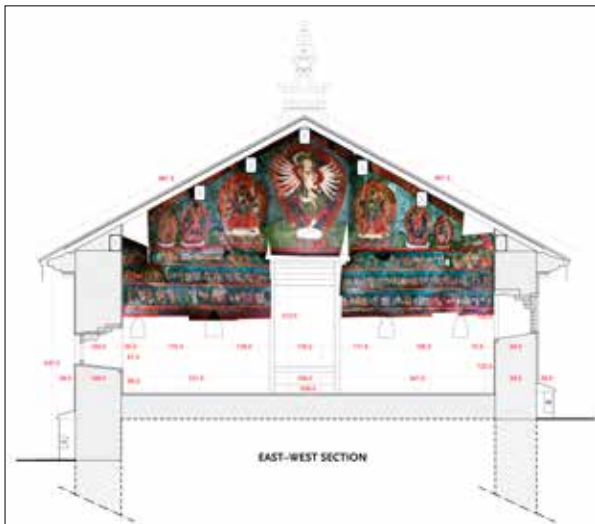
Fig. 4. East-West section of Śāntipur Temple vestibule's South wall before the earthquakes of 2015 © Pierre Gérard Bendele, Ludovic Dusuzeau/UNESCO Kathmandu, paintings images: courtesy of A. von Rospatt

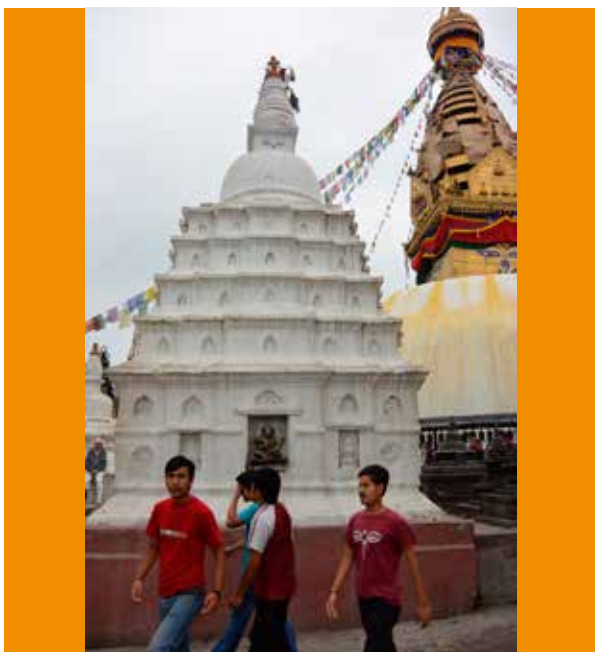
Fig 6. Tashi Gomang Stūpa. South side. October 2013.
© D. Andolfatto

One of the most damaged structures at Svayambhū is probably the Maṅgal Bahudvāra Caitya (also locally known as Tashi Gomang, Tib: the “many auspicious niches”) (Fig. 6).

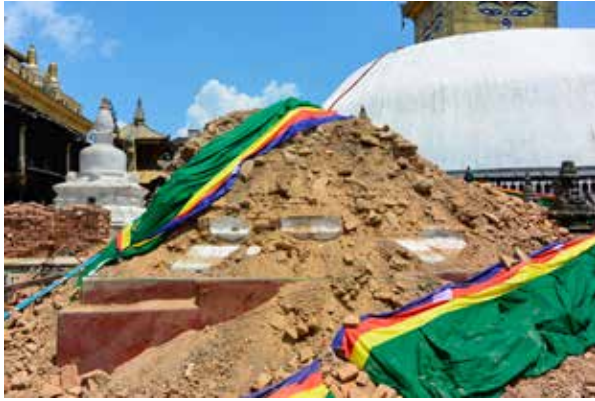
The core of Maṅgal Bahudvāra Caitya Stupa, as the excavation revealed, is a square tower of bricks punctuated at a certain level by nine hollow boxes

Fig 7. Tashi Gomang Stūpa shortly after its collapse. 1st May 2015. © D. Andolfatto/UNESCO Kathmandu

(Fig. 7 and 8)*. The central box is that of the Mount Meru or “axis mundi”. It has a narrow cavity to the centre that goes 2.30 meters deep. Miniature clay images representing *stūpas* or deities, known as *tsha-tshas* in Tibetan, were found placed in small numbers in the nine depressions. Massive quantities of these votive objects were found in the masonry enclosing the brick core. Some of the *tech-tshas* represent Buddhist gods and goddesses (Fig. 9). Coins of different origins were also discovered: British Indian quarter annas of 1862 CE, silver rupees of early 18th century Mughal Emperors. This very unique stūpa must have been built (or rebuilt) during the 1860’s or 1870’s CE, as H. A. Oldfield, who describes Svayambhū between 1850 and 1863 CE does not mention it. A more in-depth study of the objects kept at the Maṅgal Bahudvāra Caitya Stūpa will provide more information regarding the multi-cultural environment of the 19th century CE Svayambhū.

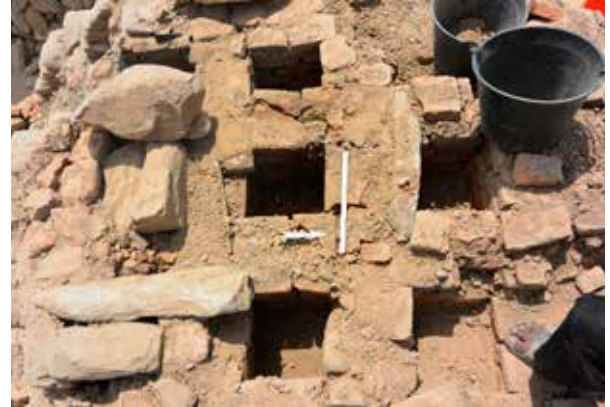
Fig 8. Top view of Tashi Gomang Stūpa after archaeological cleaning. Large stones were covering nine recesses. © D. Andolfatto/UNESCO Kathmandu

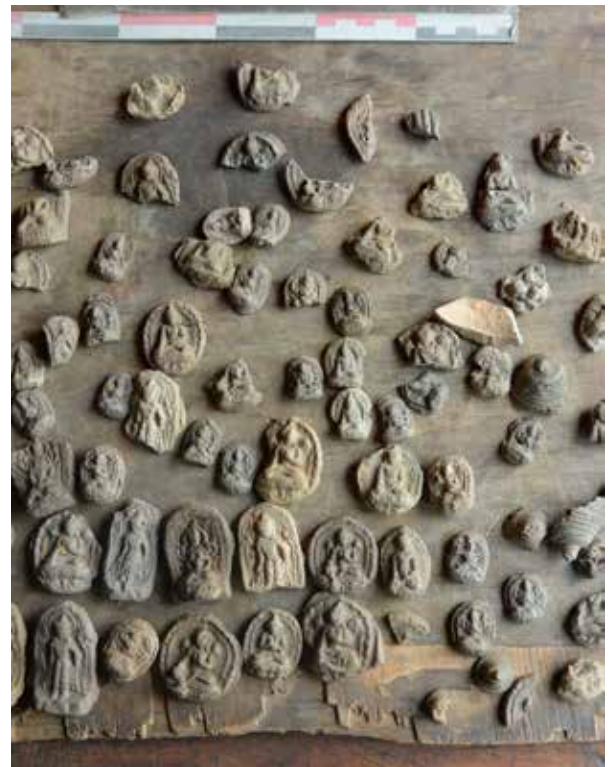
Fig 9. Some of the numerous votive clay objects (*tsha-tshas*) found in the debris of Maṅgal Bahudvāra Caitya Stūpa. © D. Andolfatto/UNESCO Kathmandu

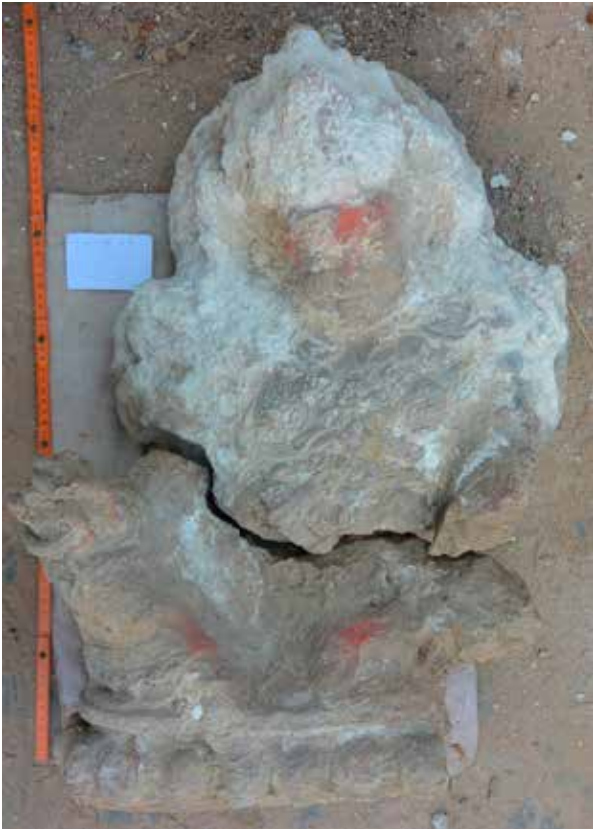
Fig 10. One of the terracotta images that was found in the masonry of Tashi Gomang Stūpa. It probably represents Virūpaṅka, one of the four Mahārājas, acting as guardians of cardinal directions. © D. Andolfatto/ UNESCO Kathmandu

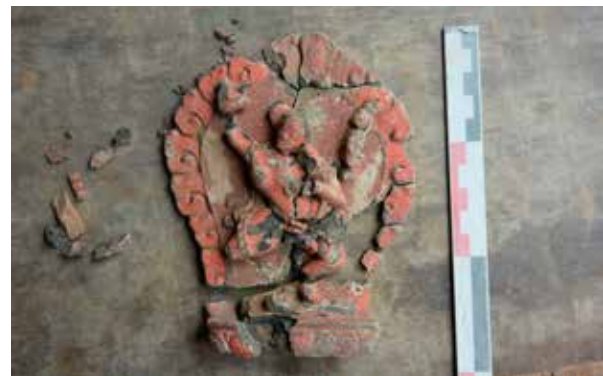
Fig 11. Painted clay image of Vajravārāhi found in one of the recesses from Tashi Gomang Stūpa. © D. Andolfatto/ UNESCO Kathmandu

* The 9, 17 or 25 square holes are often found in foundation stones of Sri Lankan stūpas (Snodgrass 2007, 129-131). Little information is available concerning foundation stones in Nepal. Contrary to Sri Lankan stūpas the Maṅgal Bahudvāra Caitya inner boxes do not contain any images of *dikpālas* or of the four cardinal animals (lion, bull, elephant and horse). These were found in the form of fine clay sculptures set between the brick core and the façade, *i.e.* in the masonry (Fig. 10). The only image that was excavated from the inner boxes is a fragmented painted clay sculpture of Vajrayoginī (Fig. 11).
