Corrosion of Old Overhead Lines: Insights into Aluminum-Steel Galvanic Couple Using Electrochemical Techniques

Divino Salvador Ramírez Rico, Stéphane Heurtault, Julien Said, Yuelin Xie, Mireille Turmine, Vincent Vivier

[1.] Sorbonne Université, CNRS, Laboratoire de Réactivité de Surface, Paris, France

[2.] Réseau de Transport et d'Électricité, CNER – Département Liaisons, Immeuble Window, 7C Place du Dôme, Paris la Défense cedex, 92073, France

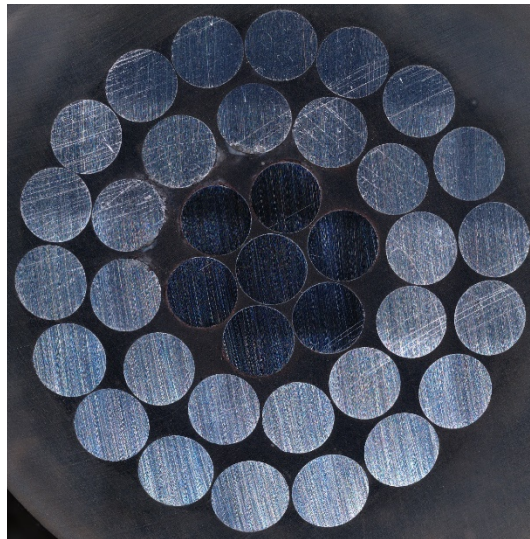
Figure 1.-Aluminum Conductor Steel-Reinforced Cable (ACRS) from CROCUS type conductor dating from 1949 provided by RTE.

After 74 years of operation and environmental exposure, the ACSR shown in Figure 1 has sustained some damage, though not enough to warrant decommissioning. The cables may start galvanic corrosion when they come into mechanical contact without lubricant. As a result, the more noble metal will act as a cathode and the less noble metal as an anode. This means that the more noble metal will corrode more slowly than it would if it were alone, while the less noble metal will corrode faster. For instance, two strands in contact, one steel and one aluminum, observed by optical microscopy are presented in Figure 2. Indeed, zinc is removed from the galvanization layer as a result of the galvanic coupling of Al and Zn, which dissolves zinc forming zinc hydroxide precipitates in high pH zones as a result of reaction (1). Depending on the electrolyte, it can produce the white deposits shown in Figure 2, the composition of which may vary depending on the nature of ions in solution [10-14]. The corrosion of the Al-Steel galvanic pair starts as soon as the zinc layer is consumed. This is demonstrated by the red oxide film that is present in both images of Figure 2.

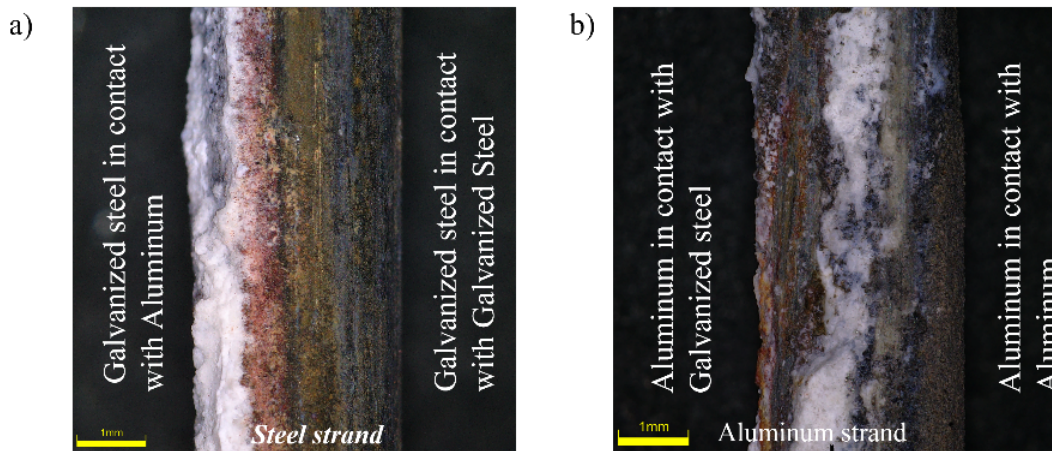
Figure 2.- Optical images of the strands in contact inside the ACSR, (a) galvanized steel strand and (b) aluminum strand.
