The Importance of Iconographic Studies for the Rehabilitation of Nepalese Heritage Monuments

David Cornélius Andolfatto

David Cornélius Andolfatto. The Importance of Iconographic Studies for the Rehabilitation of Nepalese Heritage Monuments. *The Cultural Heritage of Nepal: Before, During and After the 2015 Earthquakes. Current and Future Challenges*, 2018. hal-03900994

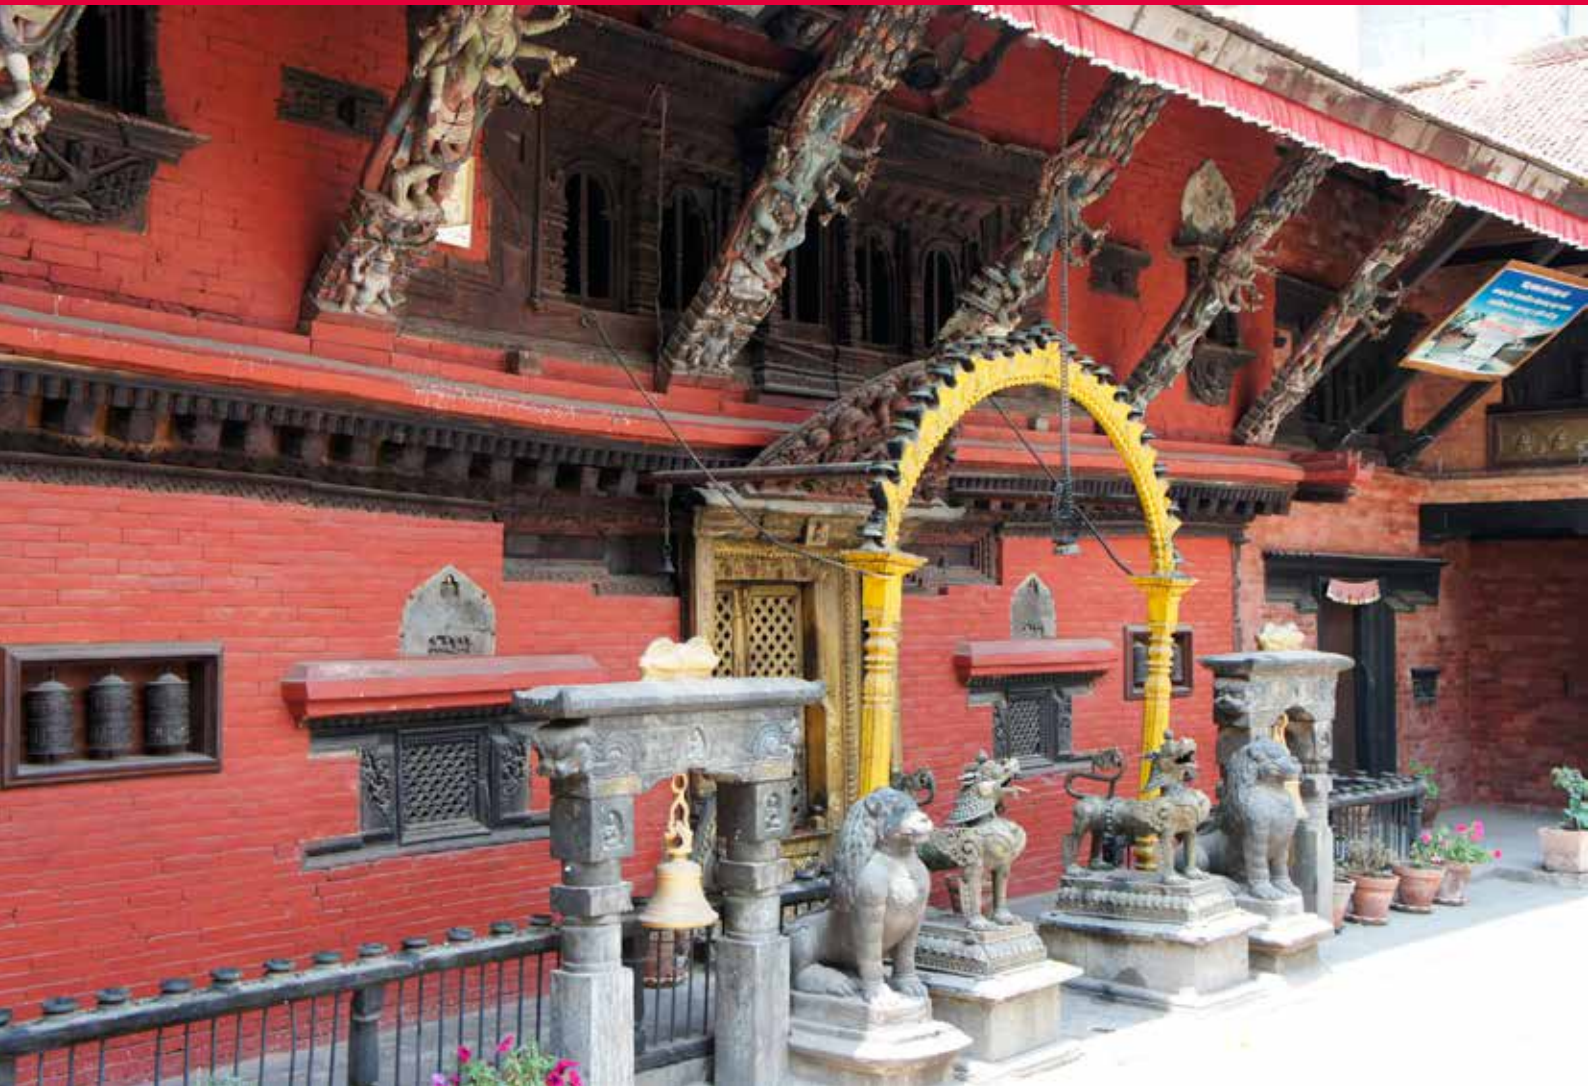
The main shrine of Itum Bahāl, located in the western wing of the complex. Six struts are placed below the roof. They represent six Pañcarakṣās or five Pañcarakṣās and one Akṣobhya. © N. Brizault.

The situation at Itum Bahāl is quite different. Four struts representing Bodhisattvas in the central part and Mahāsiddhas below are placed on the outer façade. The façades inside the courtyard have randomly placed struts representing very different styles and subjects: two Jina Buddhas, three Bodhisattvas and Mahāsiddhas, one Saptavāra and Mahāsiddha, and one Pañcarakṣā. The main shrine, located on the west wing and dedicated to Akṣobhya has the only complete iconography with six Pañcarakṣās (or five Pañcarakṣās and one Akṣobhya).

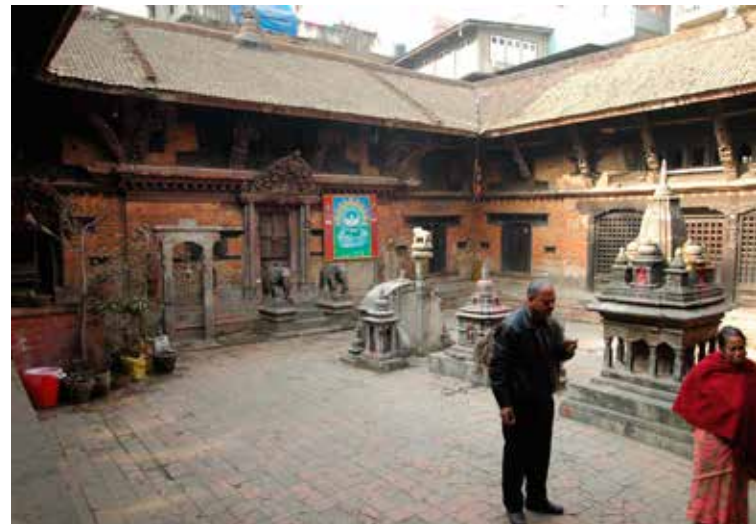
The courtyard of Chusya Bahāl (Kathmandu) and its rich set of struts. © D. Andolfatto.

At the nearby Chusya Bahāl we find five well-organized sets of struts. First of all, there is a group of ten Krodhas

or wrathful protectors, framed by Gaṇeśa and Mahākāla, protecting the façade of the courtyard's entry⁵. Inside are groups of dancers and musicians, the JinaBuddhas, the Pañcarakṣās (anthropomorphic spells) and the Saptavāras (seven days of the week, associated with a specific mantra). Though some struts have disappeared during the past decades, the iconographic program was nevertheless a complete one, of rather uniform style, emphasizing different concepts but articulated together.

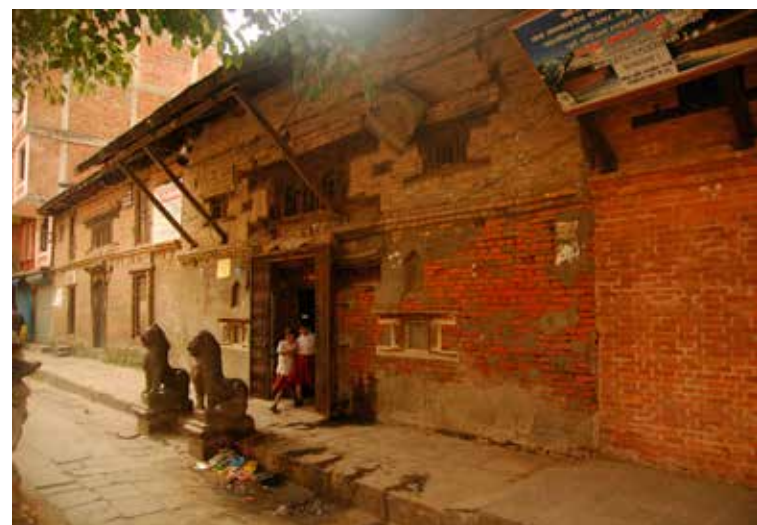
The eastern wing of Itum Bahāl (Kathmandu) before its reconstruction. Carved struts used to adorn the façade before the earthquake of 1934. Five struts now remain there. © D. Andolfatto.

Itum Bahāl was restored at different periods of its history. The reconstruction of the eastern wing was initiated in 2013 and the building dismantled in March-April 2015, just before the earthquakes, thus preventing the wing from collapsing. The Oriental Cultural Heritage Sites Protection Alliance (OCHSPA), Kathmandu Valley Preservation Trust (KVPT) and the local community are funding it. An iconographic study of the monument's struts was conducted before its restoration which revealed an absence of homogeneity in both styles and subjects⁶. The hypothesis is that the
